**Barunga West
Council**

Coastal Protection Initiatives

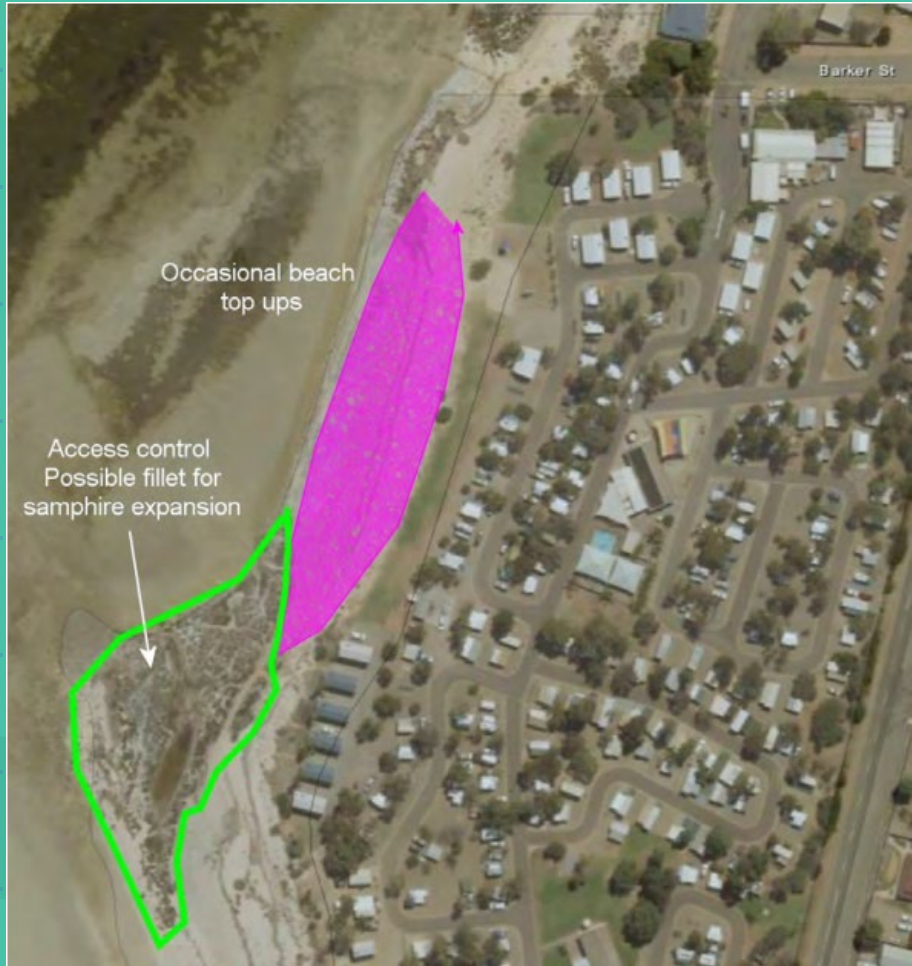
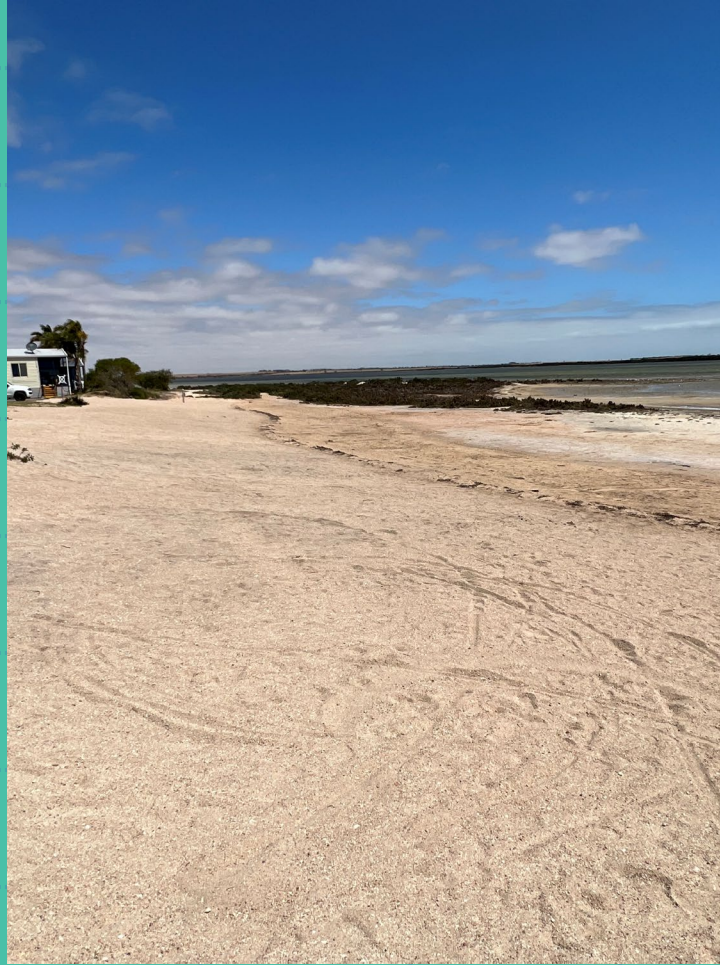
Tourist Park

- Stage 1: 400m³
- Stage 2: 400m³
- Stage 3: 400m³

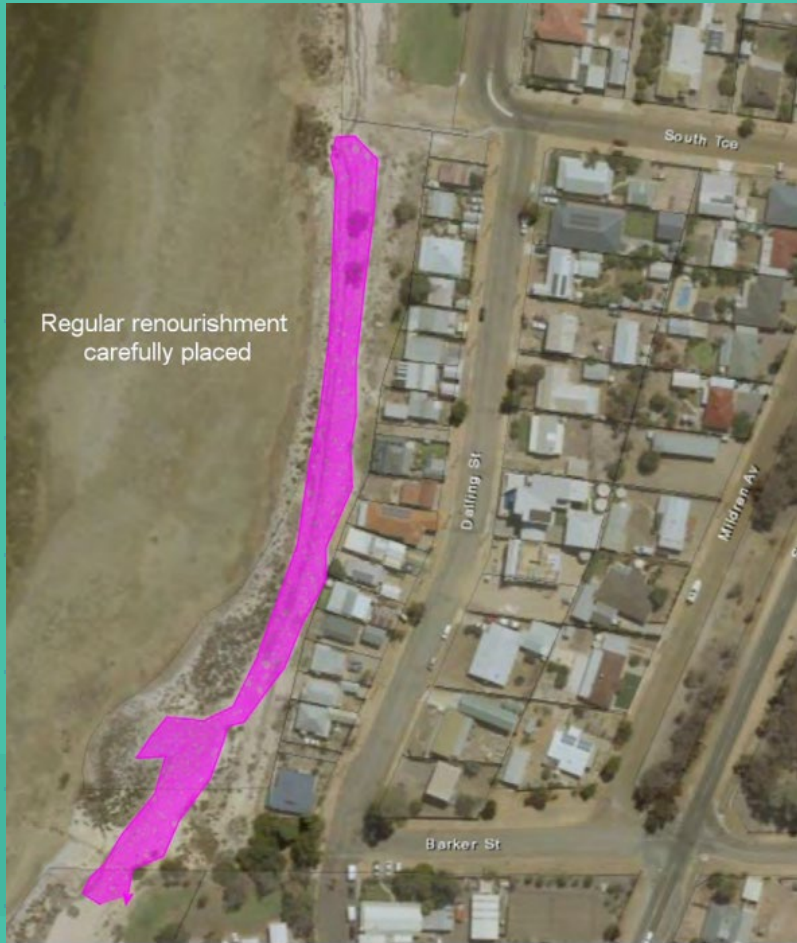
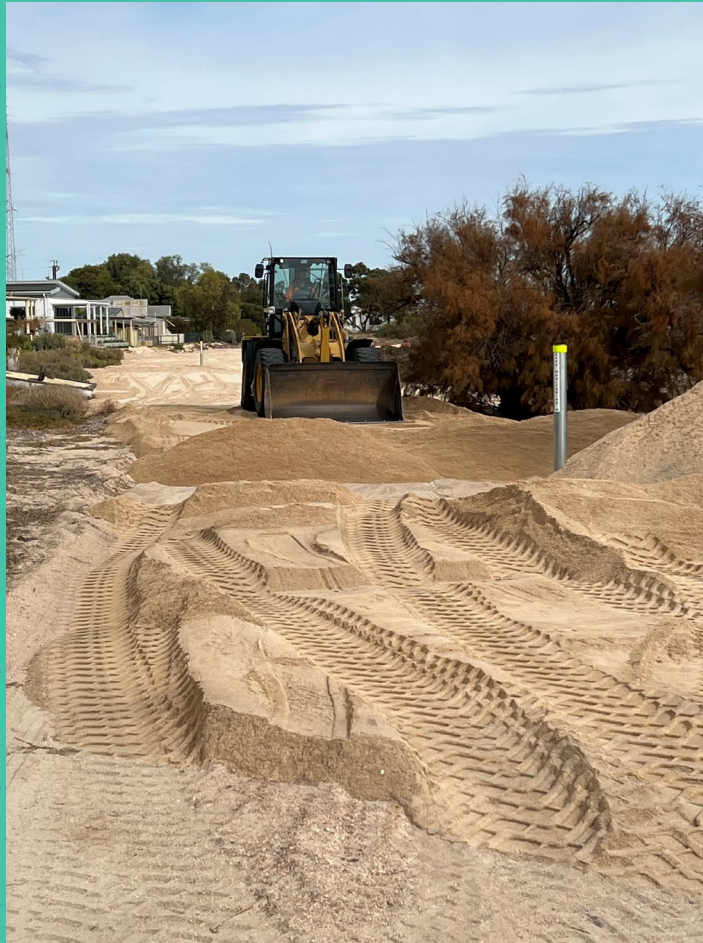
Dalling Street

- Stage 1: 600m³
- Stage 2: 600m³
- Stage 3: 600m³
- Stage 4: 600m³

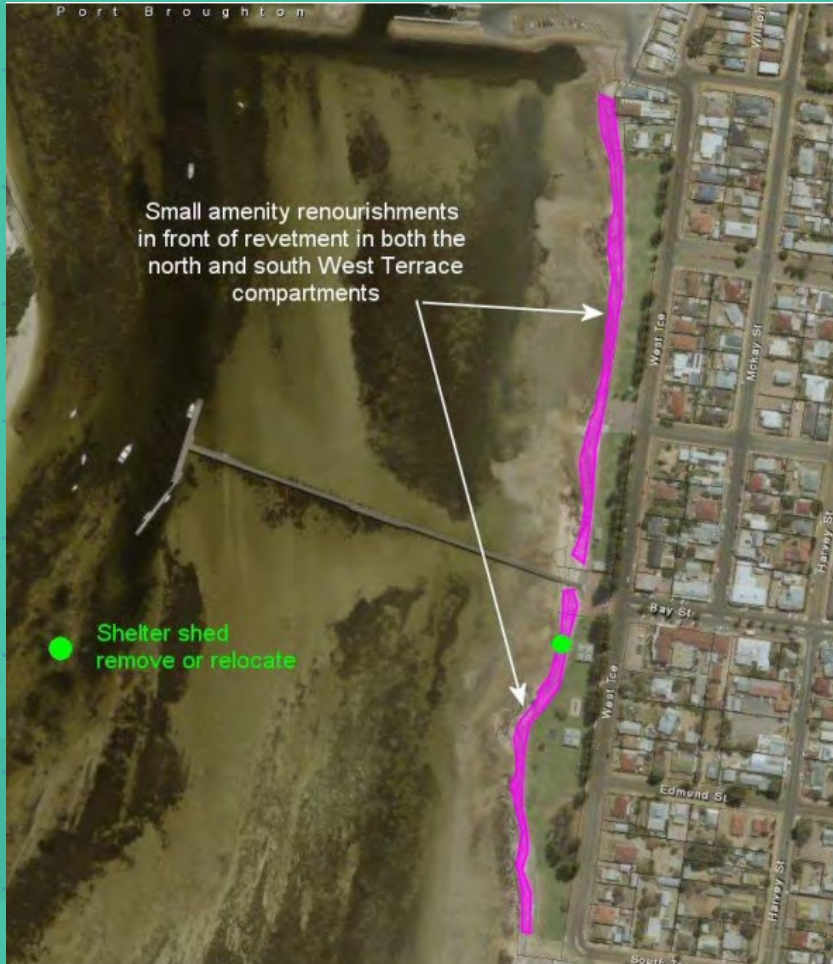
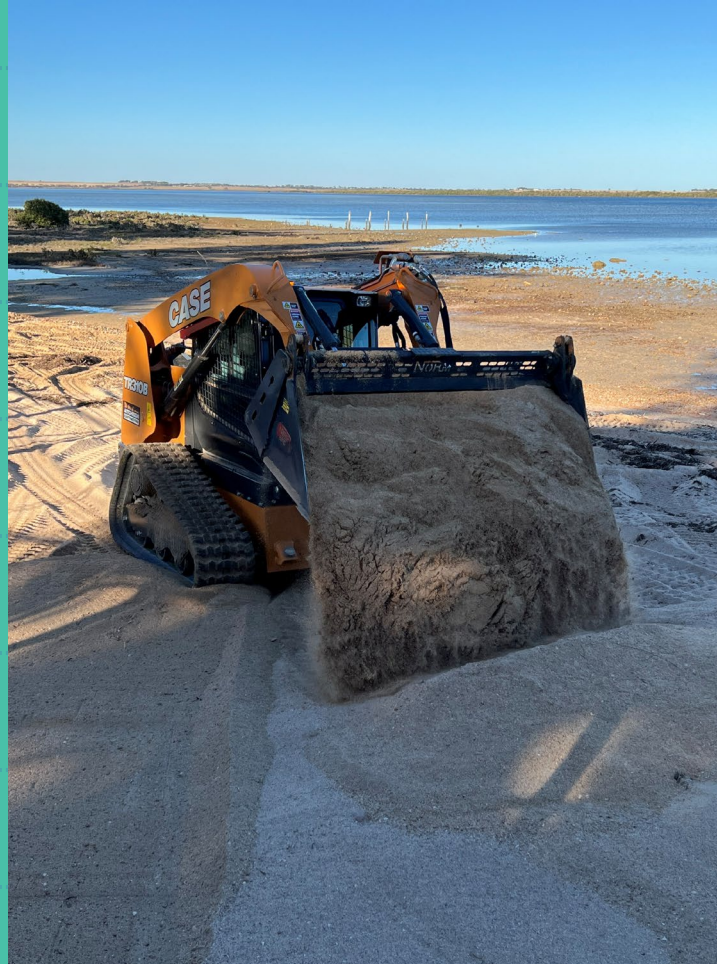
West Terrace

- Stage 1: 600m³
- Stage 2: 600m³
- Stage 3: 600m³

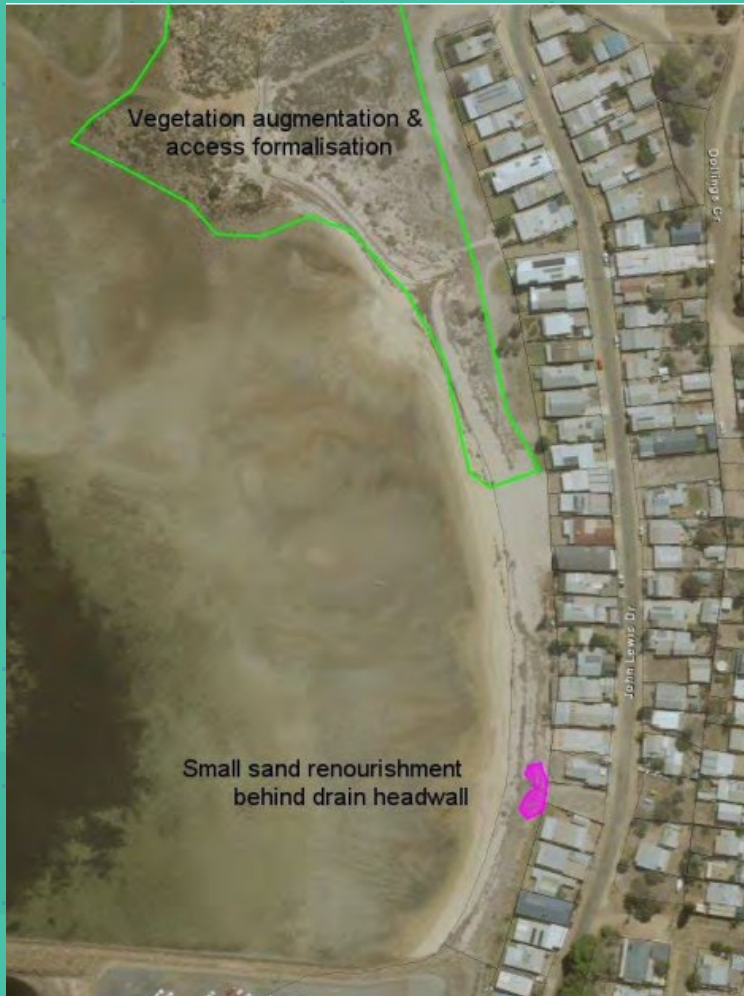
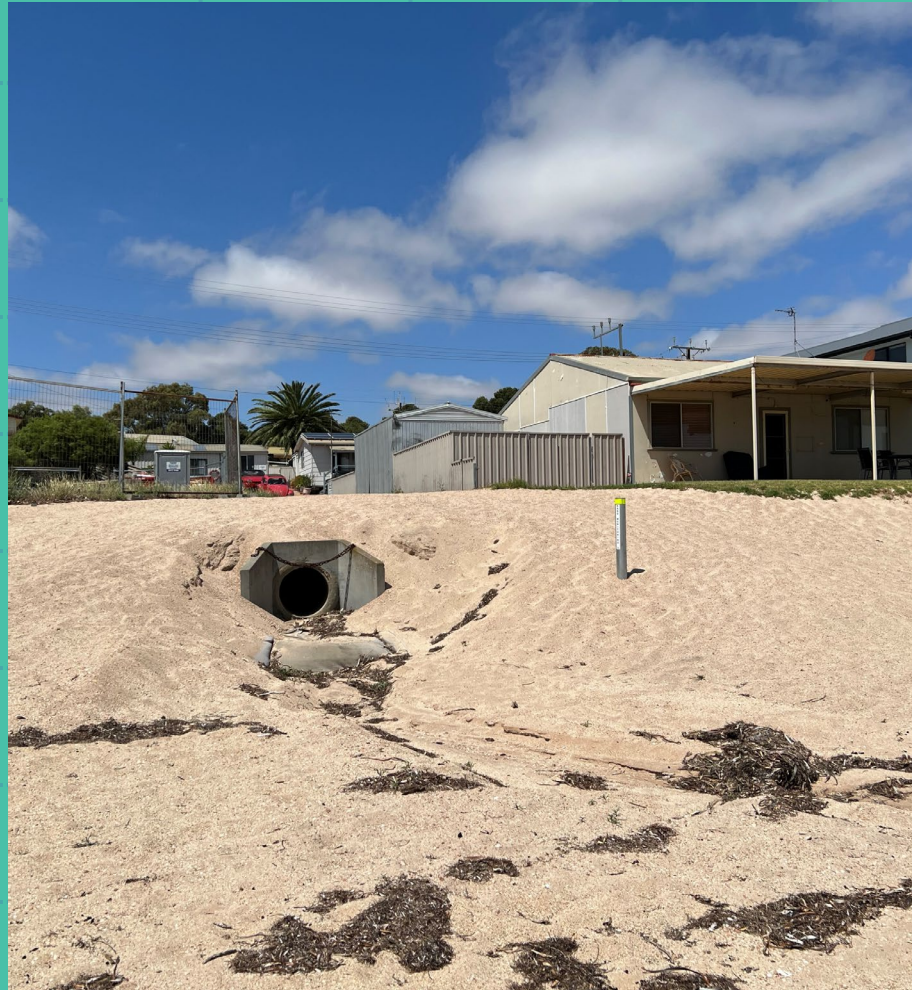
John Lewis Drive

- Stage 1: 100m³
- Stage 2: 100m³
- Stage 3: 100m³
- Emergency (storm 17/10/24): 100m³

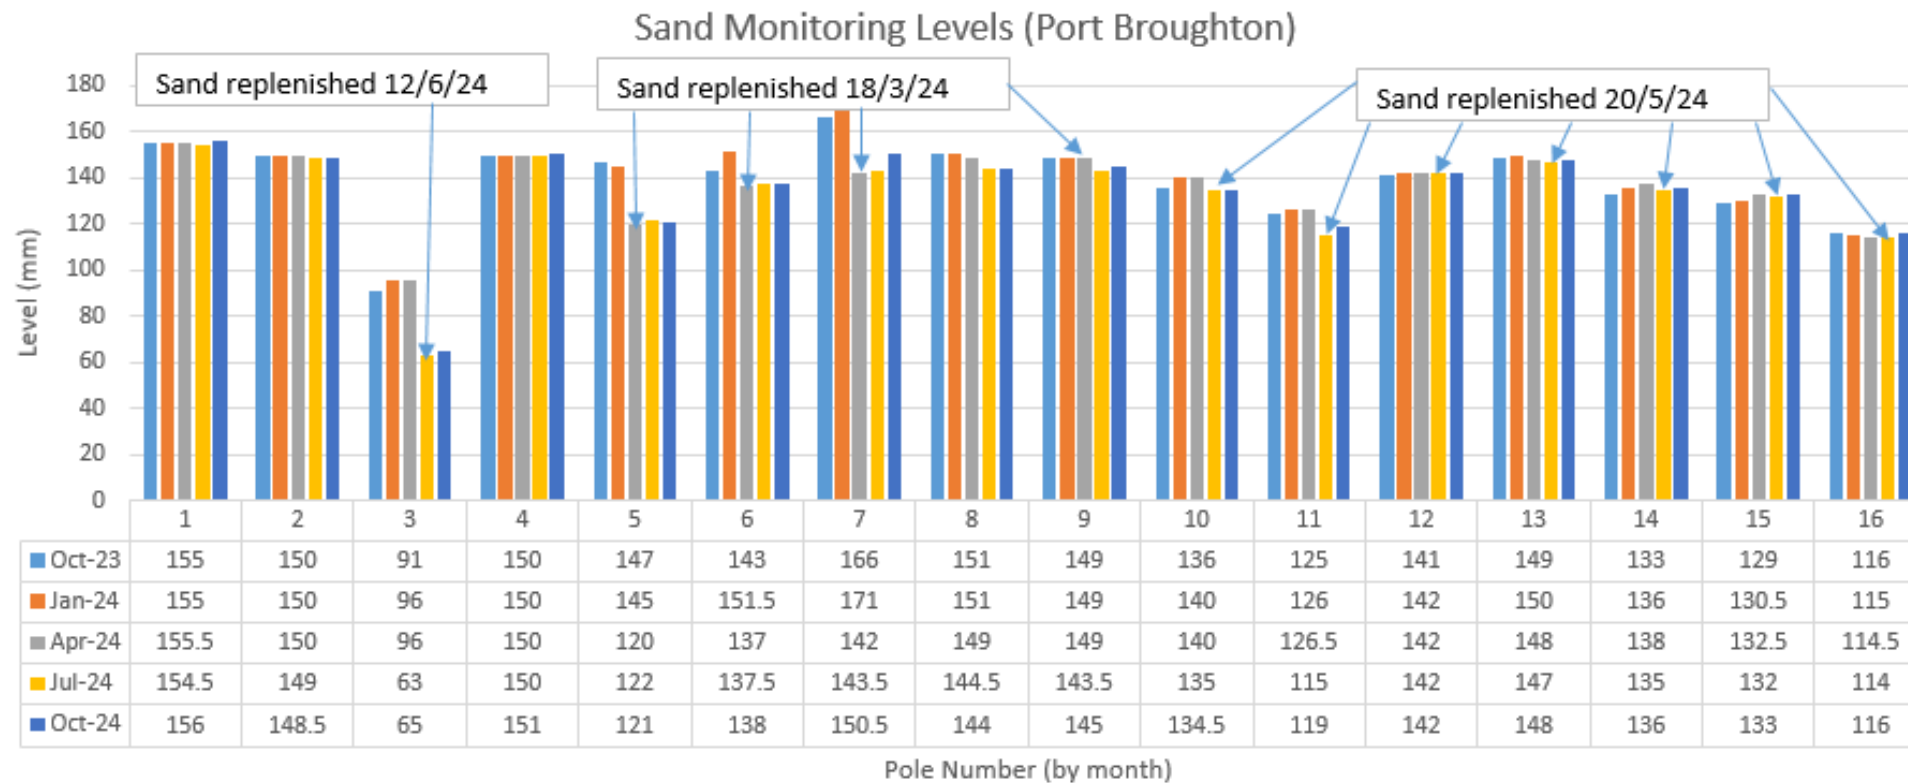
Sand levels 2023 - 2024 (chart compiled 22 October 2024)

1	JLD1
2	JLD2
3	JLD3
4	WTN1
5	WTN2
6	WTS1
7	WTS2
8	WTS3
9	WTS4
10	DS1
11	DS2
12	DS3
13	DS4
14	TP1
15	TP2
16	TP3

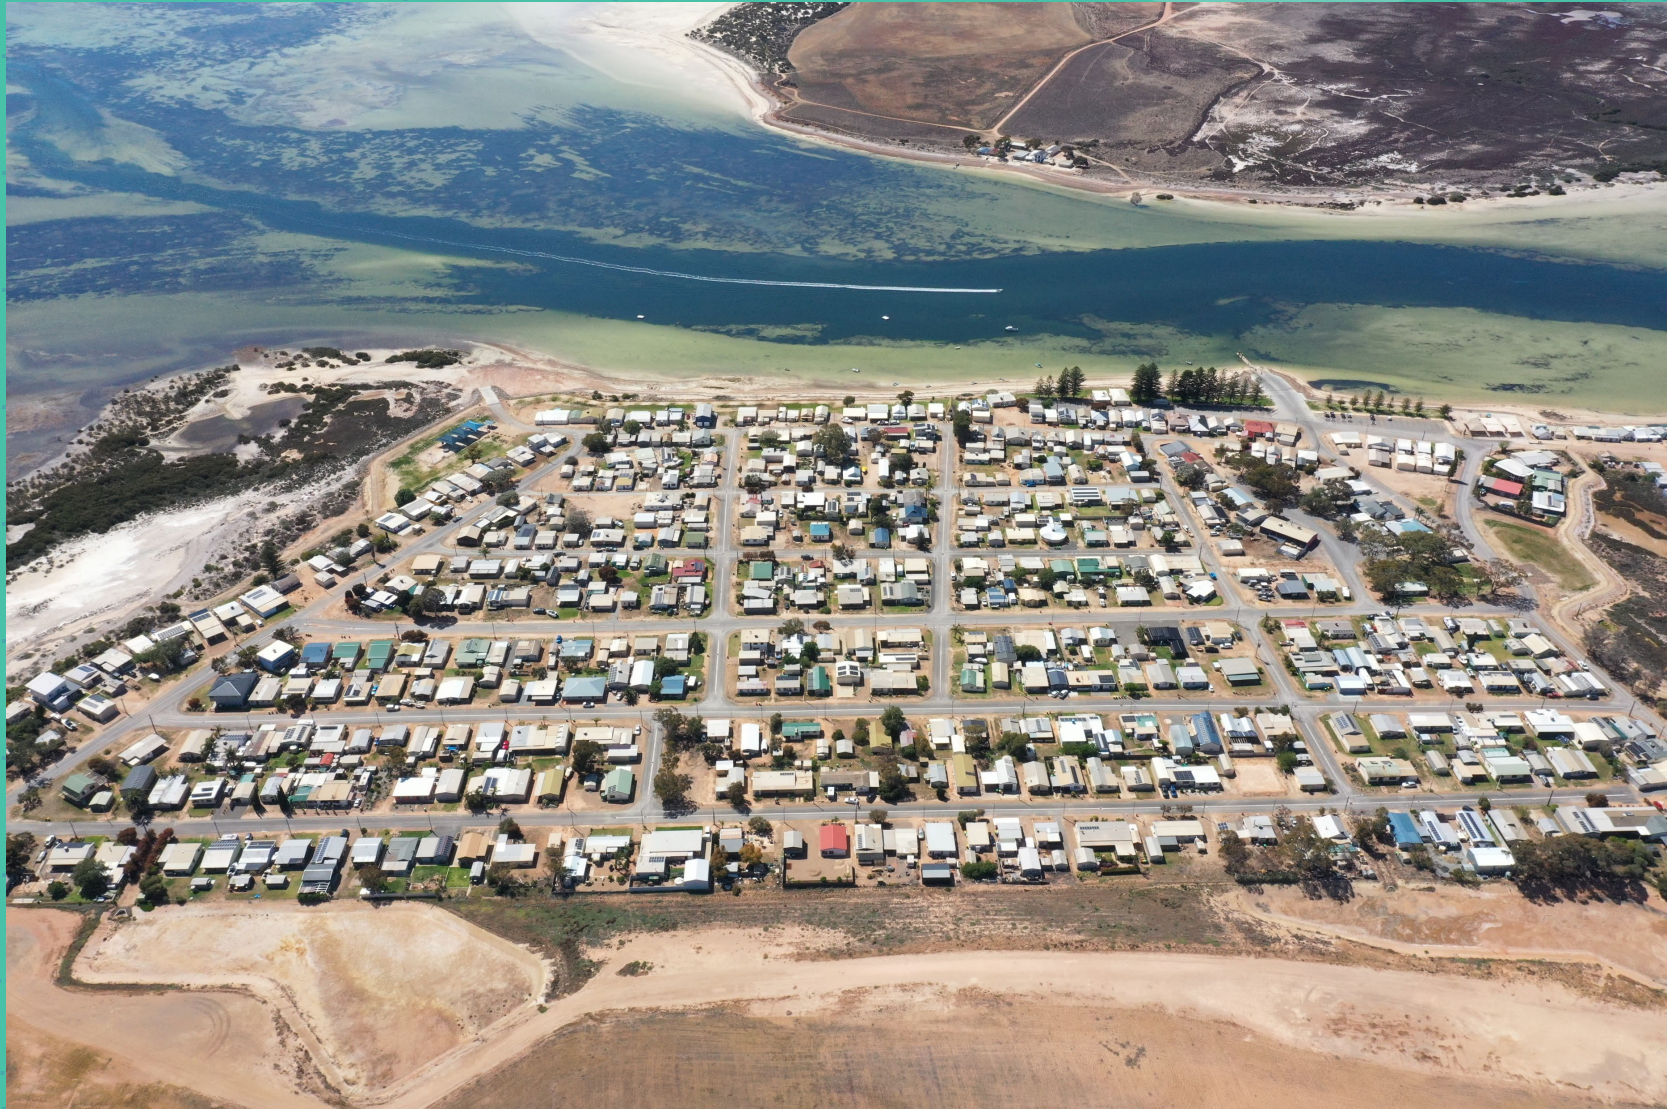
- Seawall

- Part of Fisherman Bay Freehold Process (2015):
 - Seawall and earthen levy + stormwater management

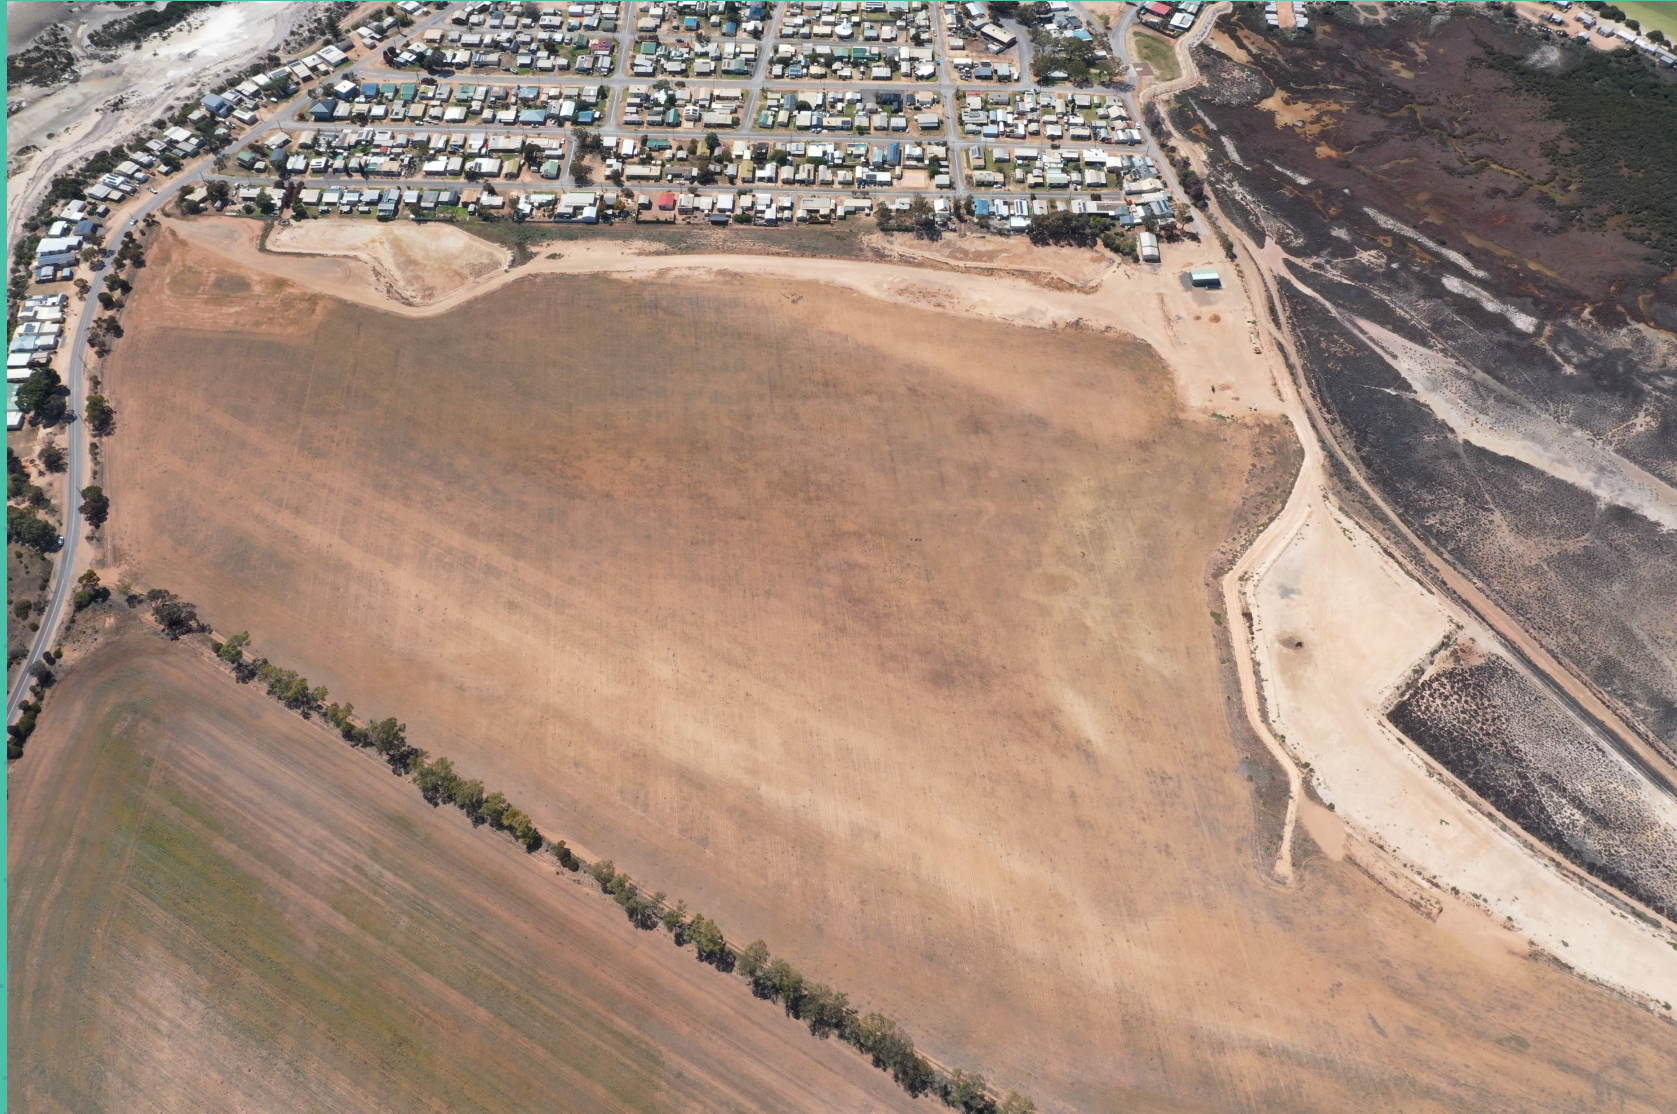
- Earthen levy

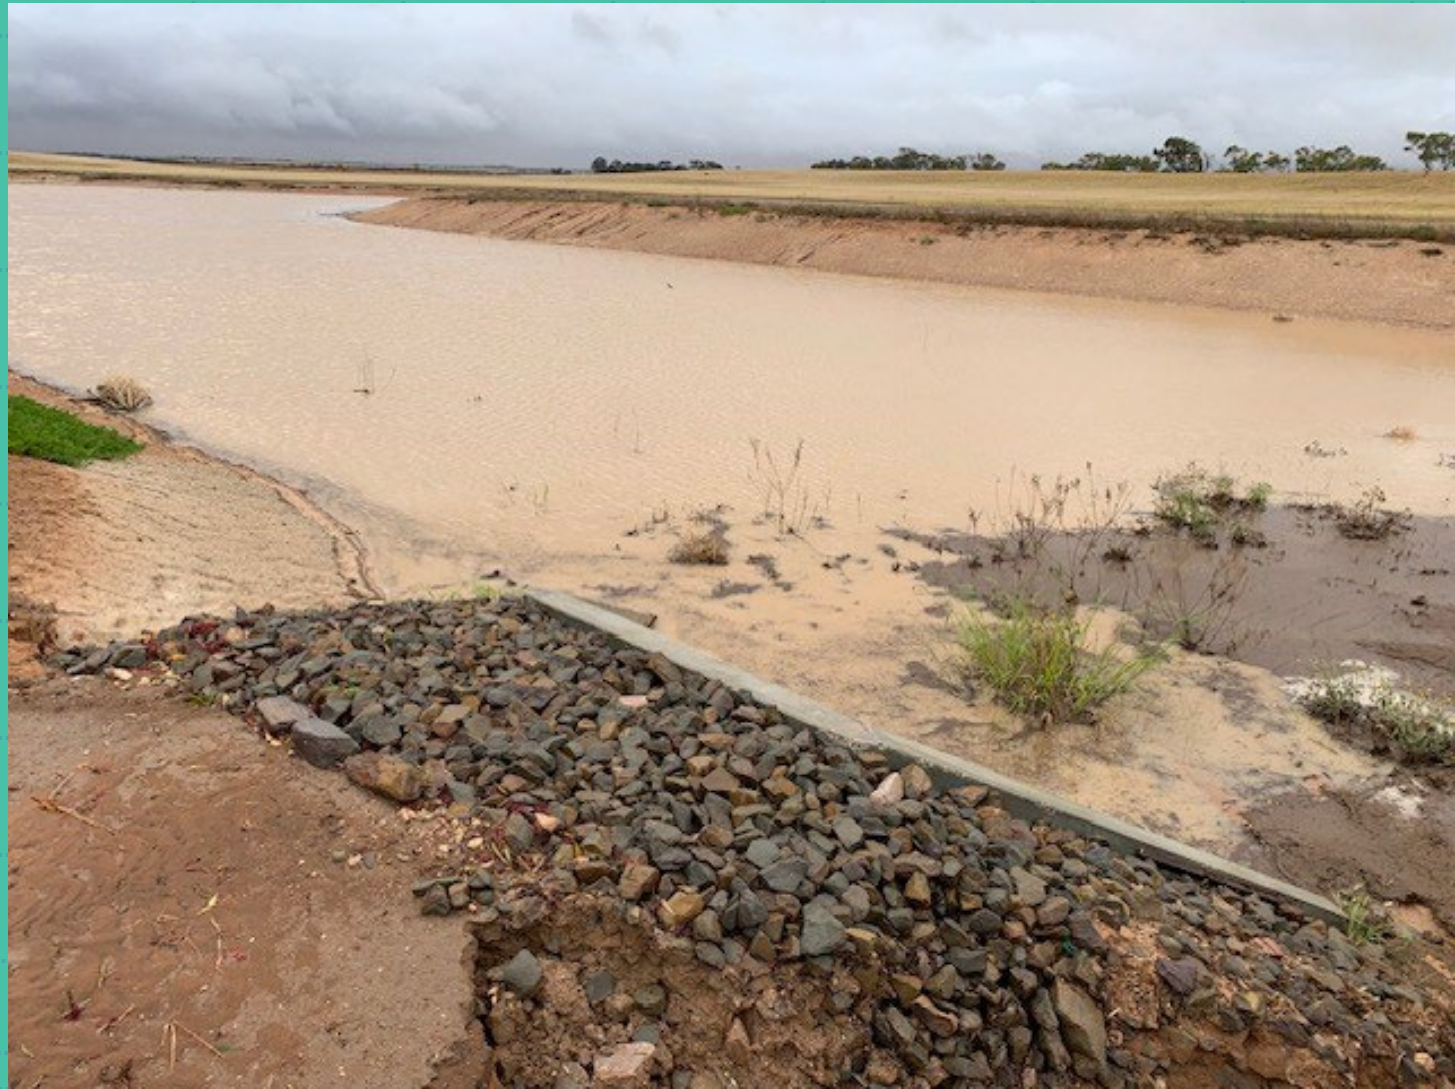
- Stormwater pond (after storm on 17 October 2024)

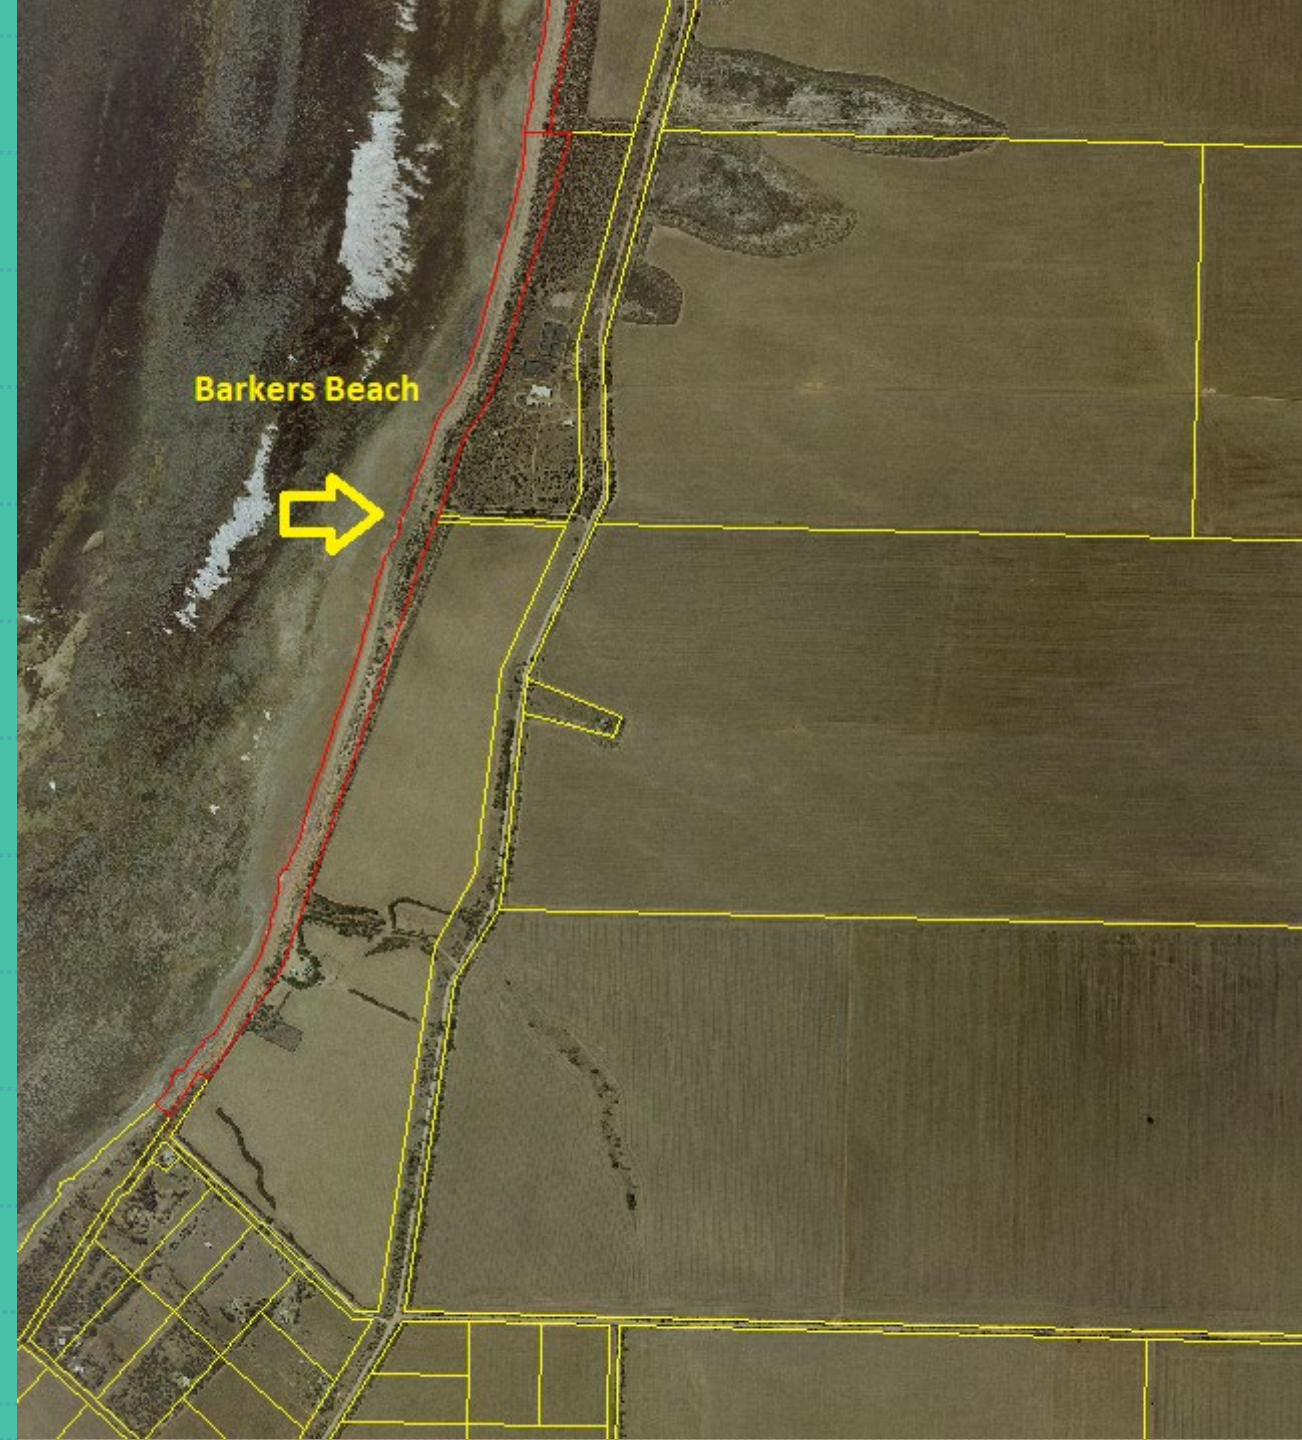
Blue line is the proposed fence. Fence will need to be robust enough to deter vandalism, but relatively affordable to repair or replace given likelihood of vandalism. Red line is bollards/posts delineating the day area. Posts around day area will ensure that area looks 'tidy' and actively cared for.†

Red pins are probable points of entry that will probably need some form of reinforcement or deterrence (boulders, coir logs, bollards etc) to discourage vandalising or removing the fence. These can be moved around depending on the lay of the land.†

Revegetate tracks at visible locations with tube stock.†

Bollards to meet existing property fences, or logical start point where no room is allowed for new tracks?†

- Ban camping
- Convert to Day Visitor Area
- One access point to beach
- Fence off dune access
- Revegetate
