# Coastal Hazard Adaptation Grant

District Council  
Tumby Bay  
Community  
Focused  
Alignment Study

DISTRICT COUNCIL of TUMBY BAY

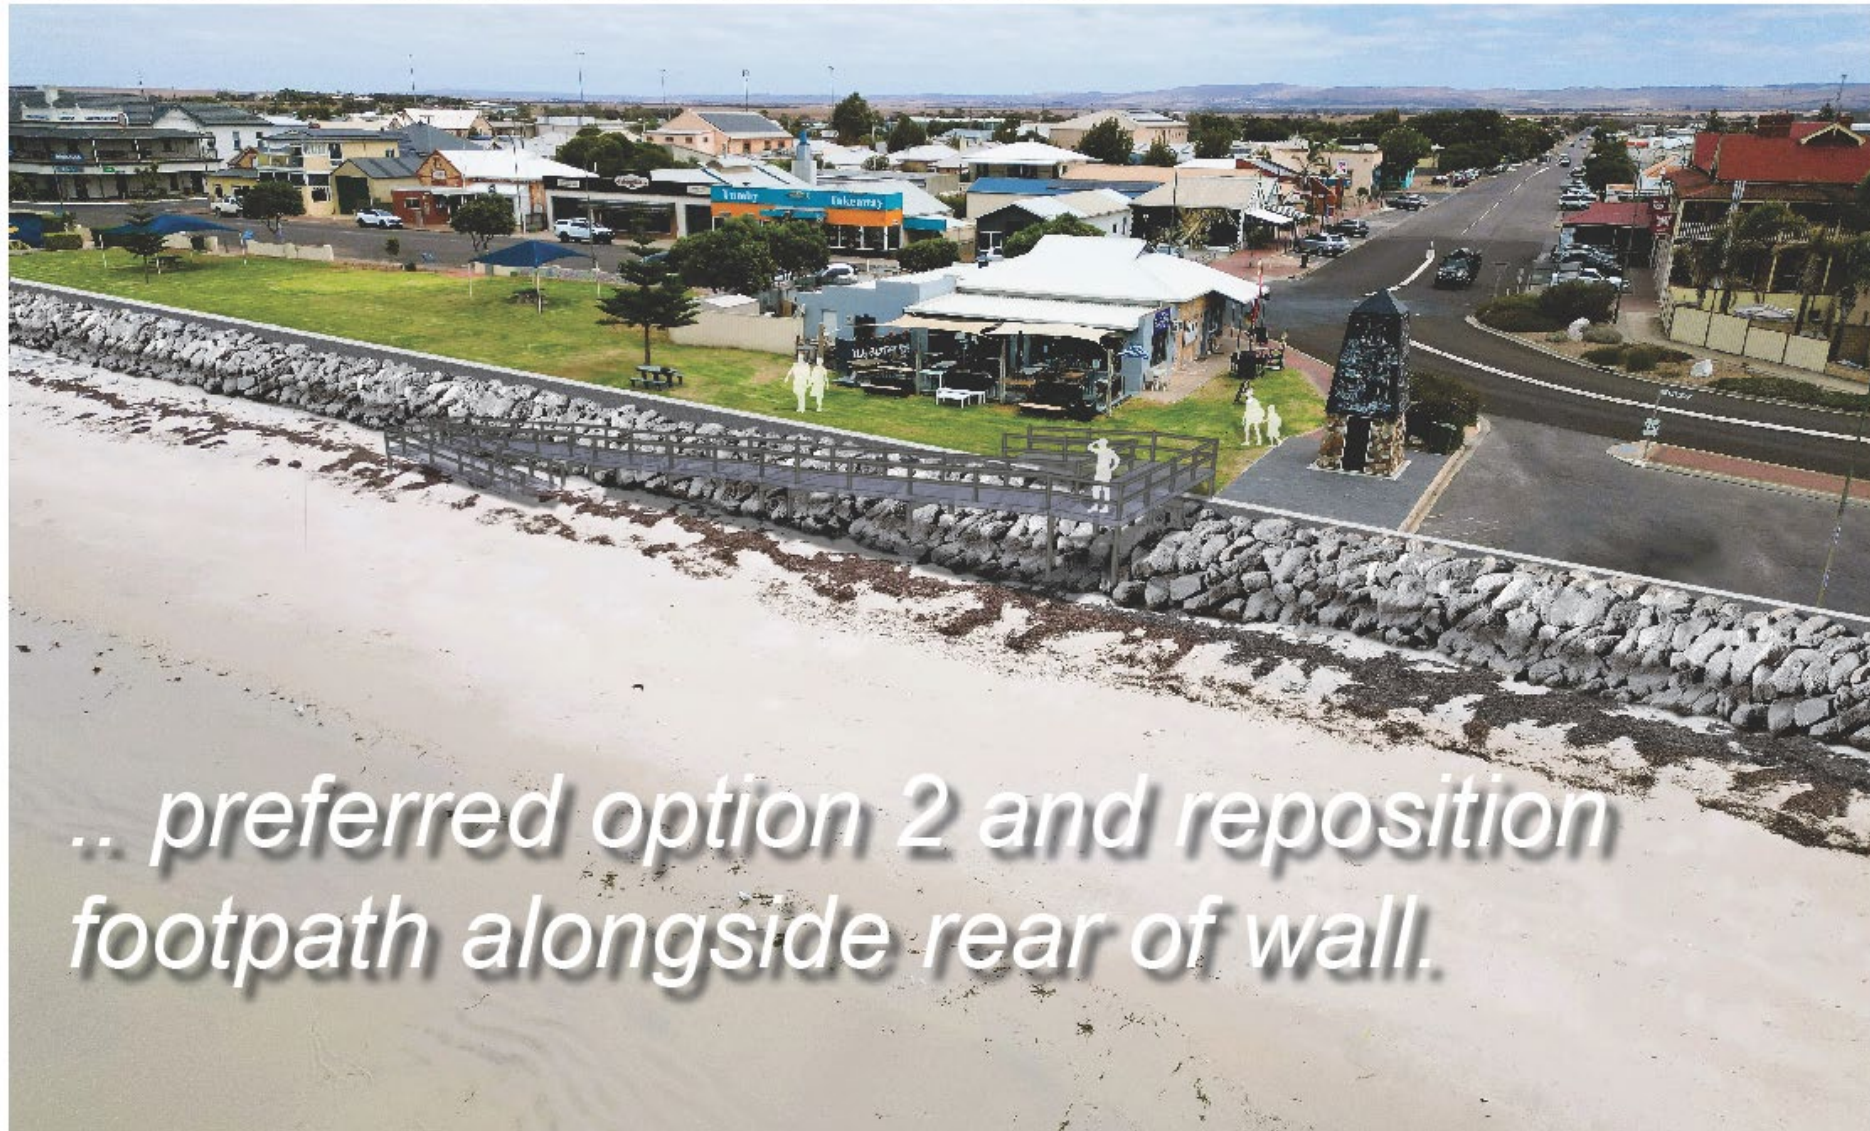
### Preferred Seawall Alignment

Community Endorsed Concept - refer to design basis report for next steps and recommendations.

*... preferred option 2 and reposition  
footpath alongside rear of wall.*

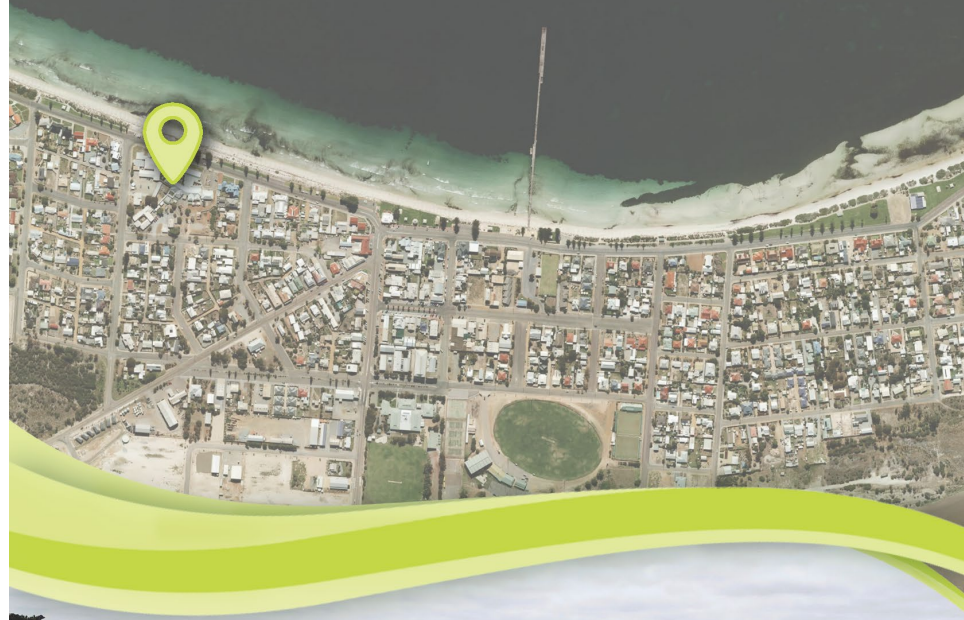
# Tumby Bay HOSPITAL

## KEY ISSUES

- Dune erosion (long-term and storm erosion)
- Loss of vegetation - washing away
- Flooding of bike path
- 1:100 ARI storm in 2100 will flood the caravan park
- Threat to Hospital infrastructure and access
