# Whyalla Foresore - Issues and Sand Replenishment Program

## 2011 - 2025

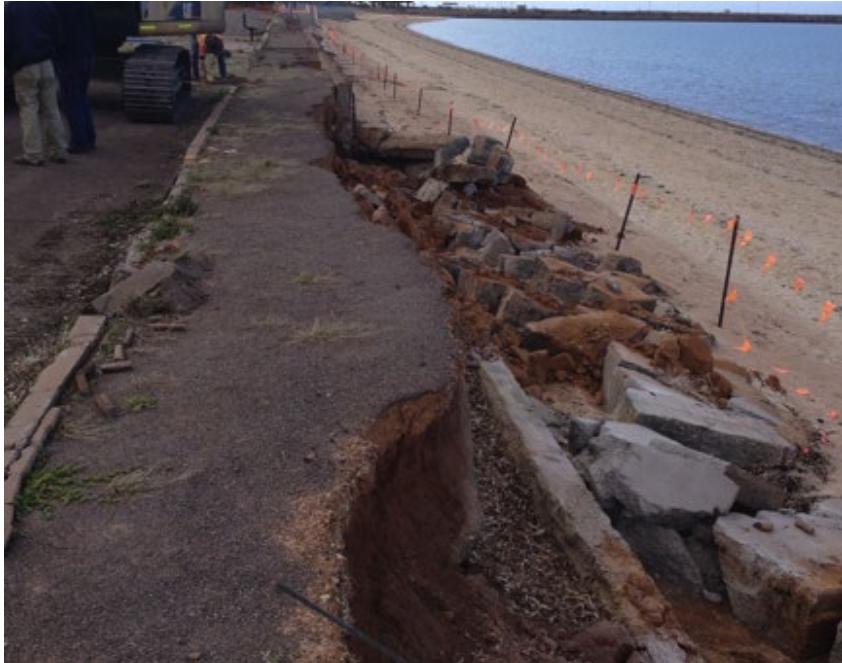
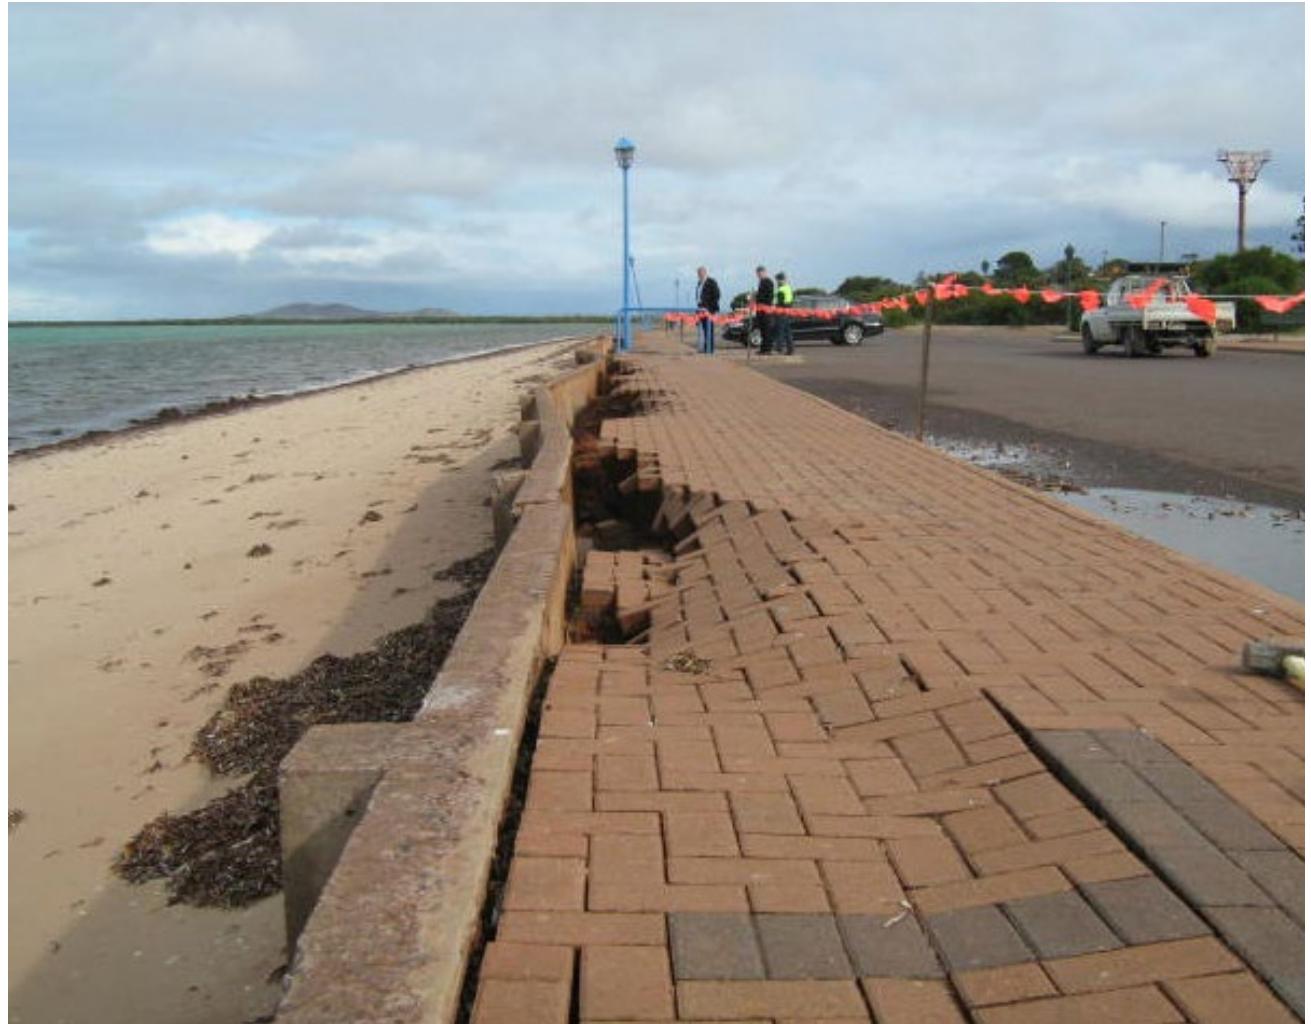
# May 2011 - High tide destroys large section of old seawall

This particular high tide swept under sections of the old seawall, removing the compacted rubble that supported the boardwalk, causing the seawall and boardwalk paving to collapse.

The damaged seawall sections were broken up and sent off to be crushed and reused as road base on other Council projects.

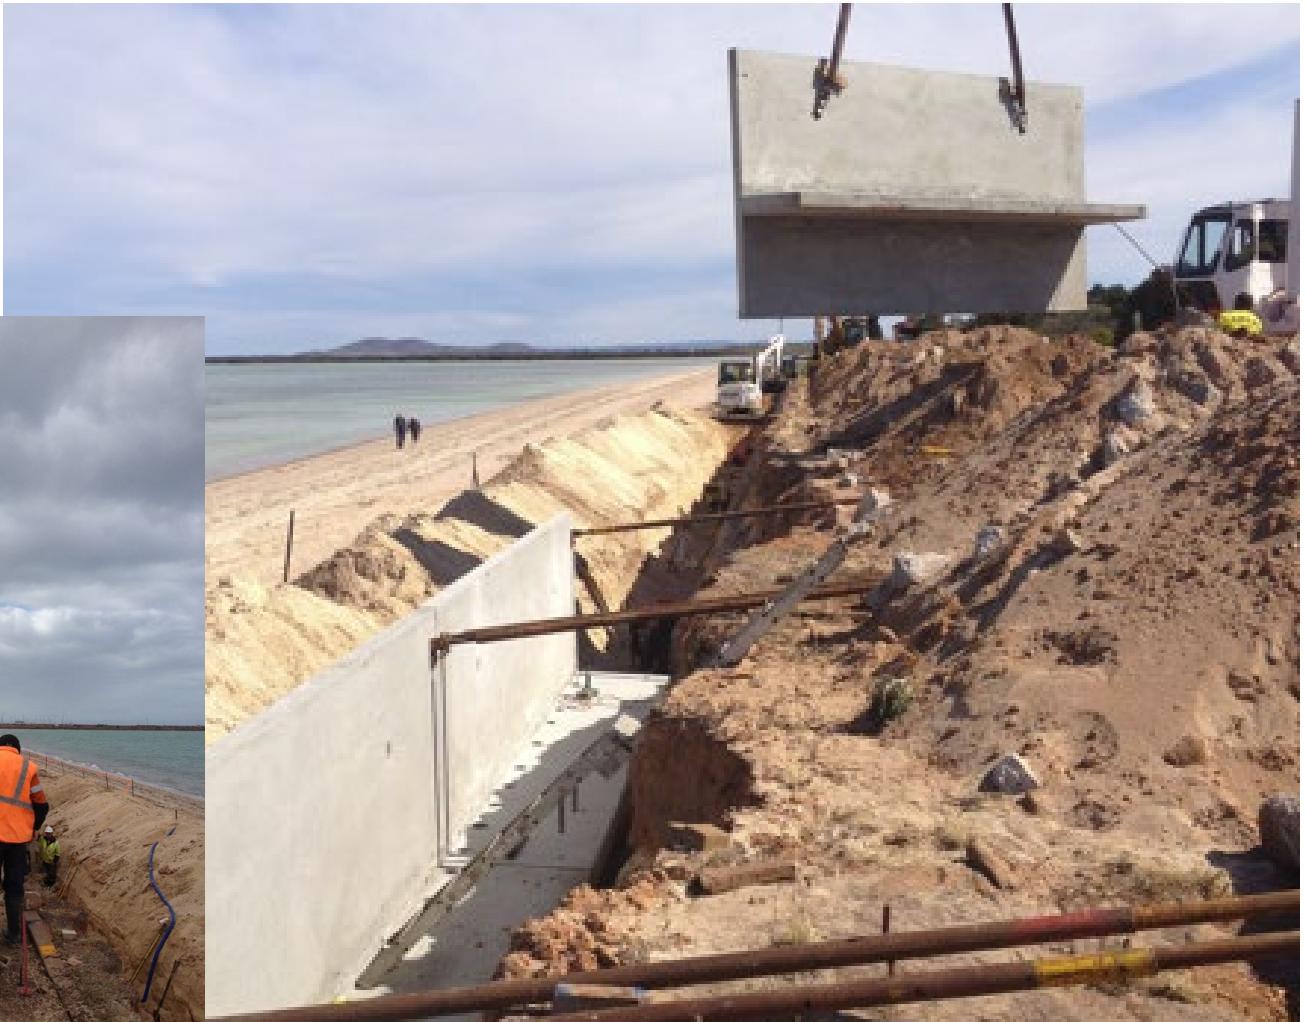
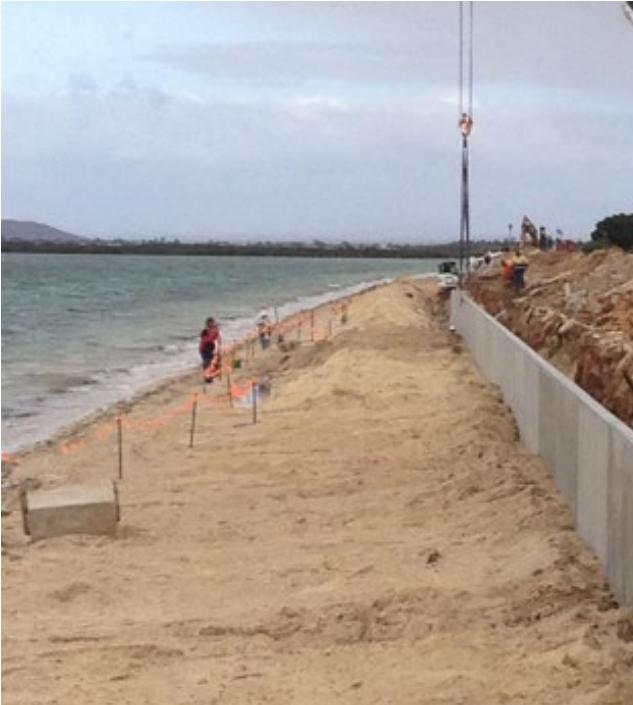
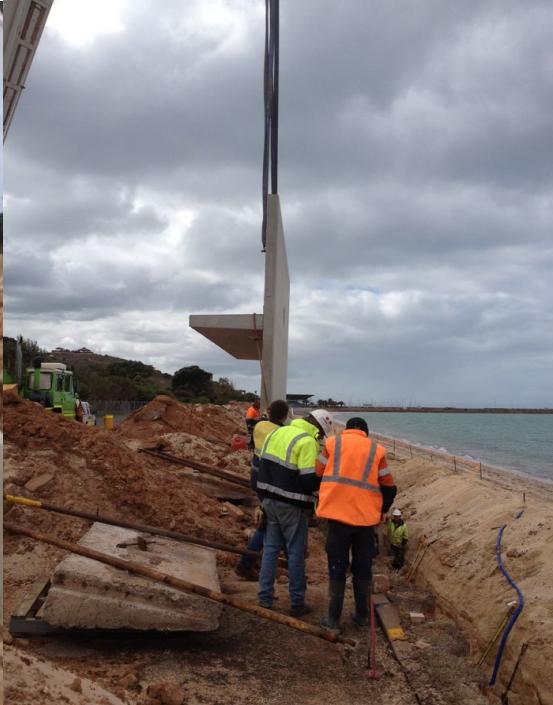
# August 2012 - New Seawall installed

New seawall sections were craned into place and compacted.

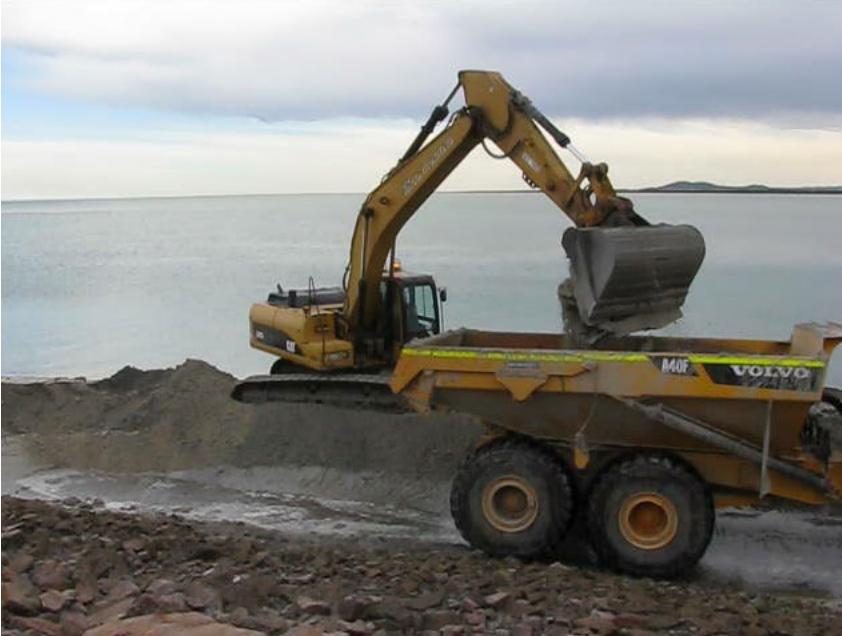
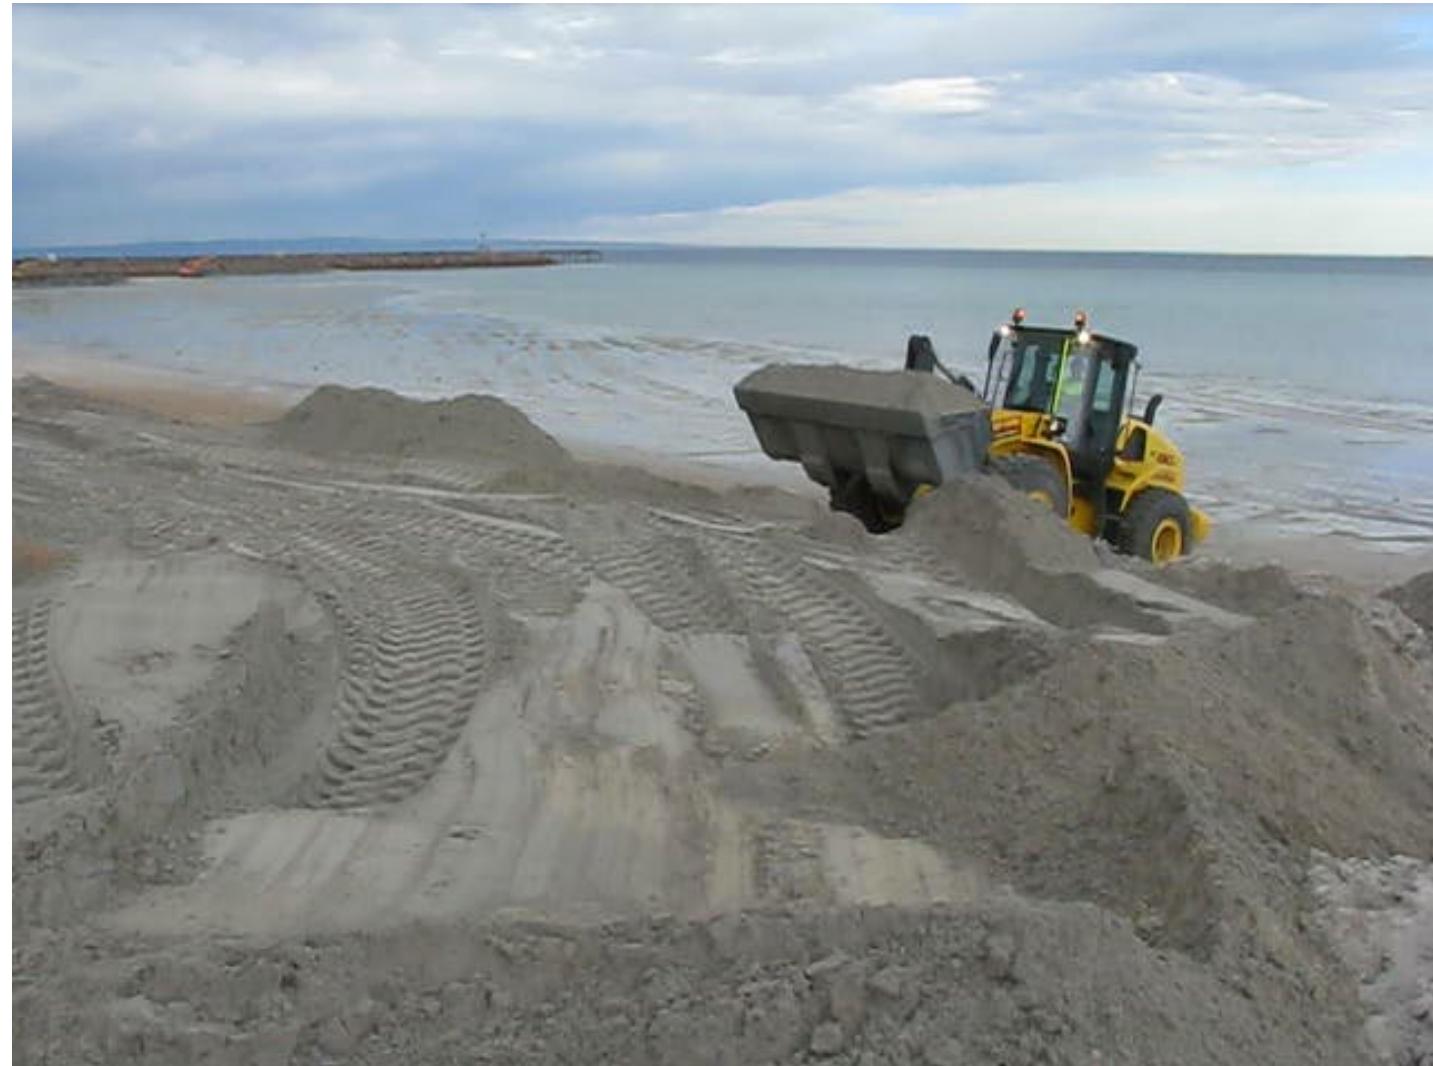
## August 2013 - First Sand Replenishment Project

This project involved the harvesting and placing 28,500m<sup>3</sup> of sand, that was placed from the Foreshore Caravan Park to the Marina Breakwater. Much of this sand is still in place, with only certain areas needing ongoing beach nourishment.

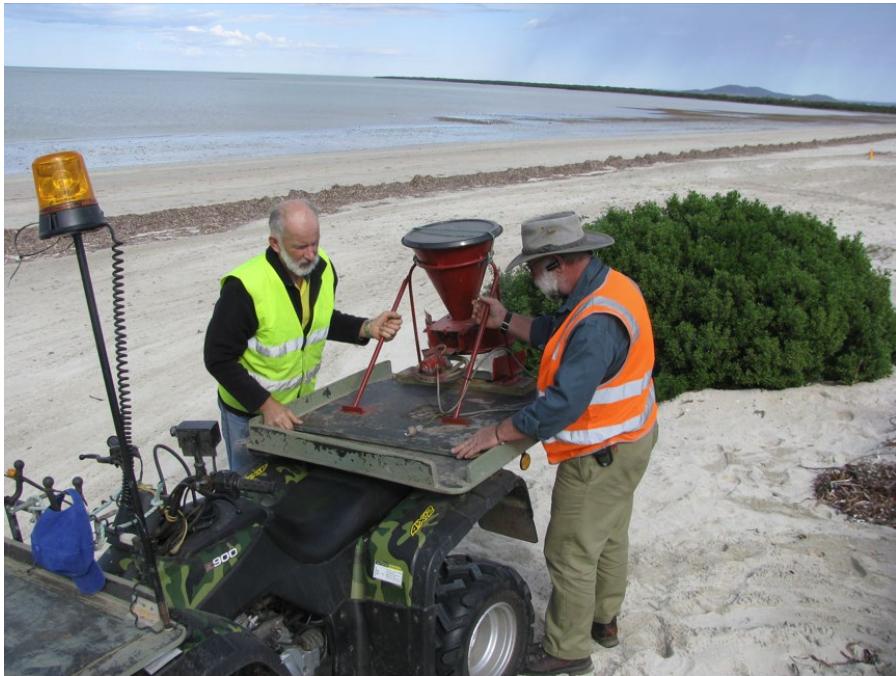
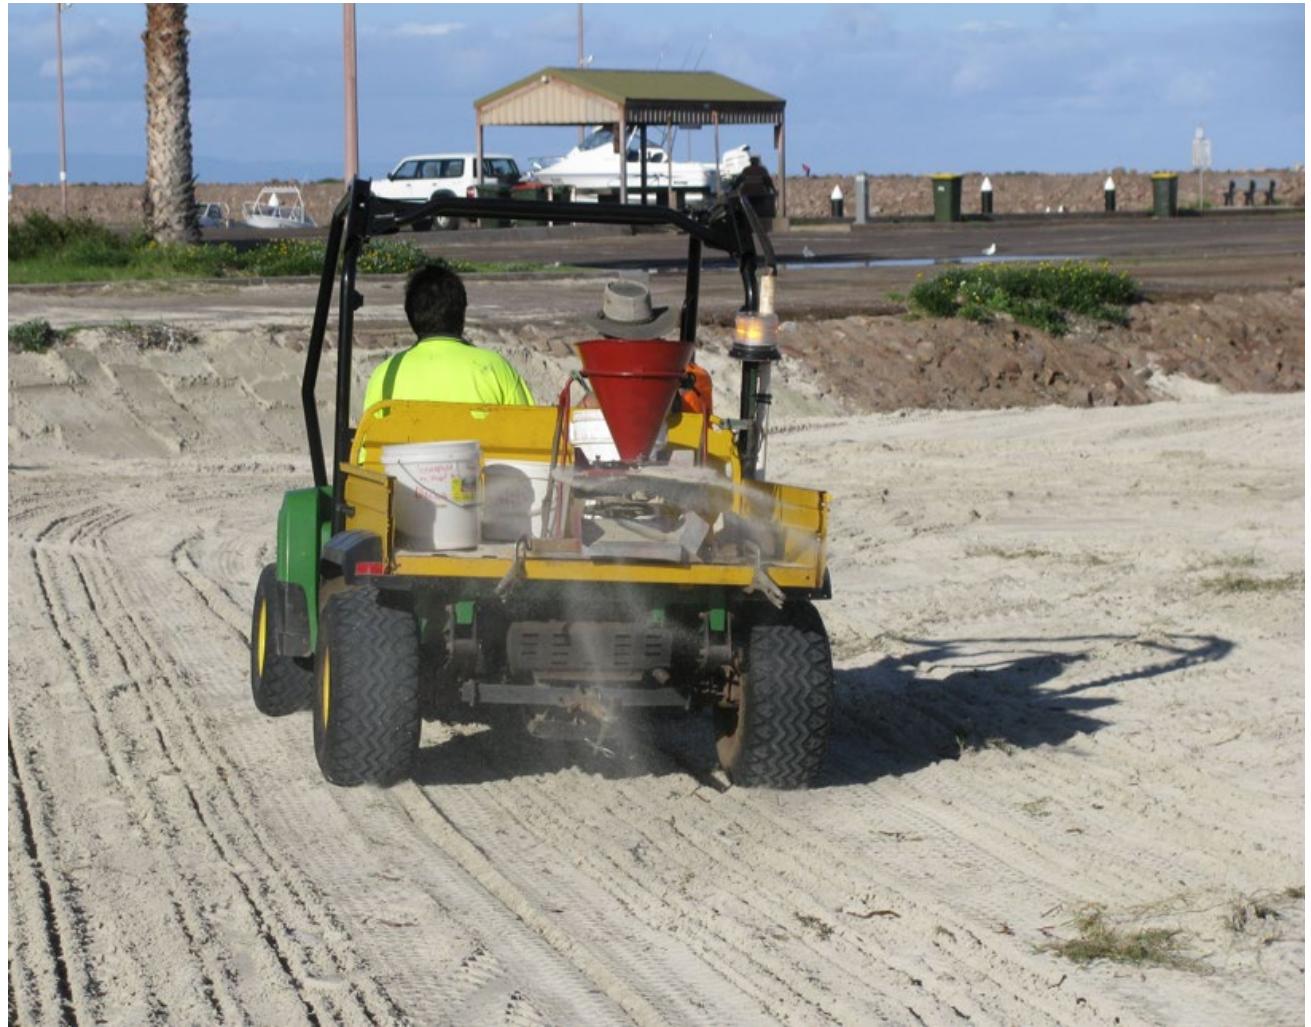
# Winter 2014 First direct seeding project

Two sections of Foresore direct seeded with local endemic vegetation

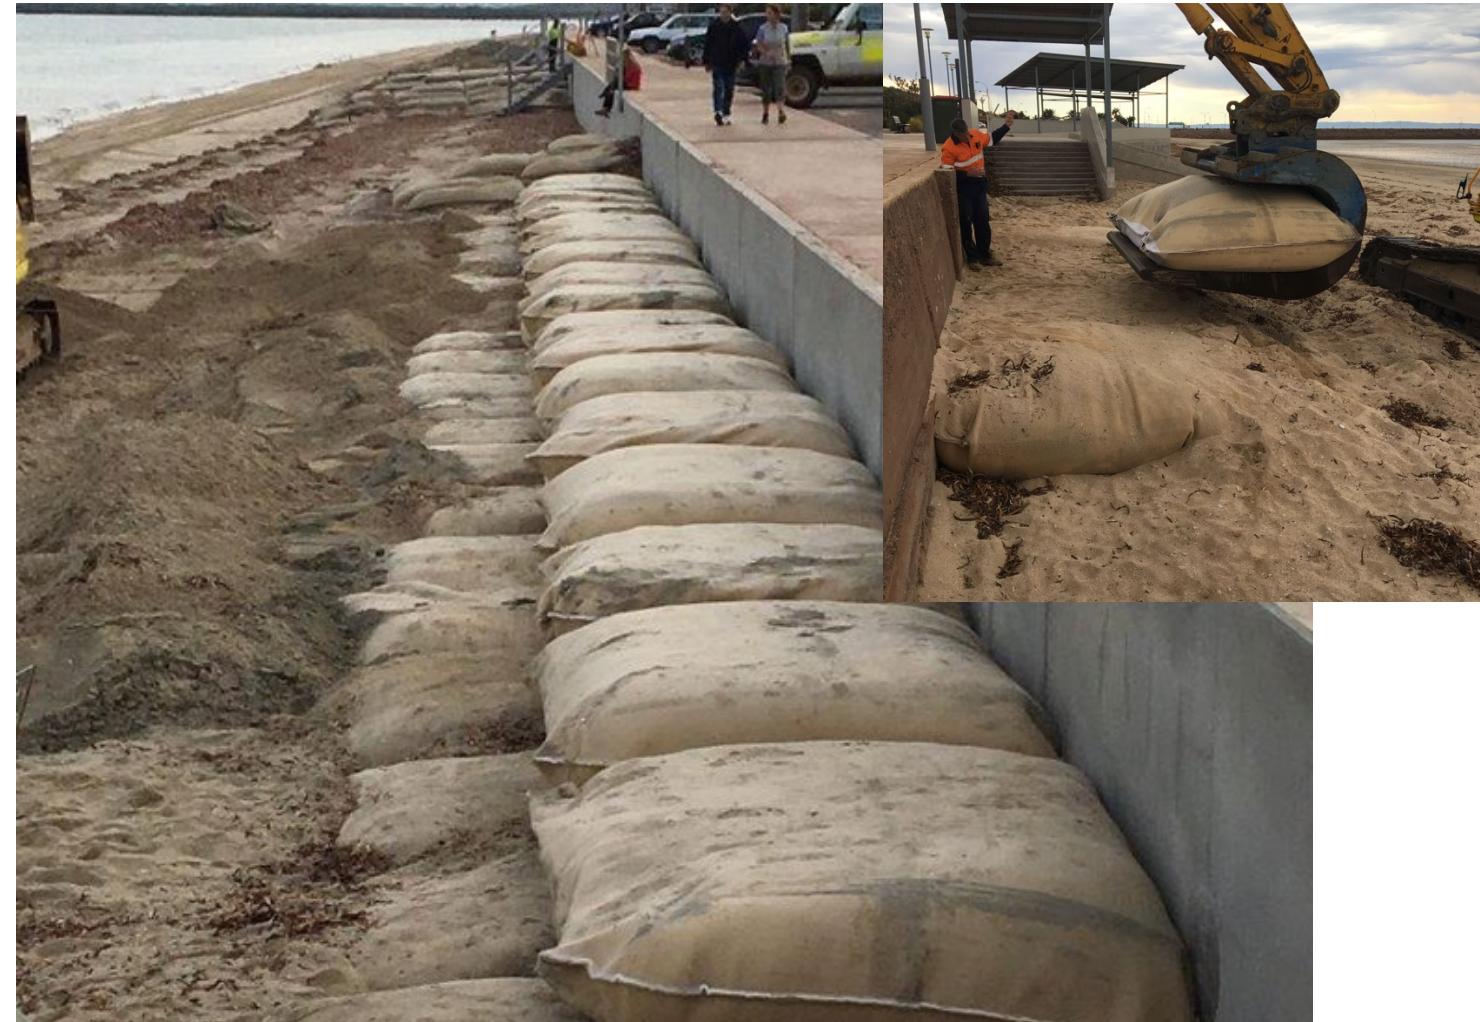
# May 2017 – 300 x 2.5m<sup>3</sup> ELCOROCK Sand Containers Installed

Installed in the most eroded sections of the Foresore, these sand containers now lock sand in place, so it can't wash away

The ongoing role of the sand containers includes -

Preventing further damage to the new and old sections of sea wall and attached infrastructure.

Minimise potential fall height from boardwalk to under 700mm from top of seawall.

Provide dune stability, allowing vegetation to establish, that helps to lock harvested and windblown sand insitu, preventing it from blowing into the promenade behind the seawall.

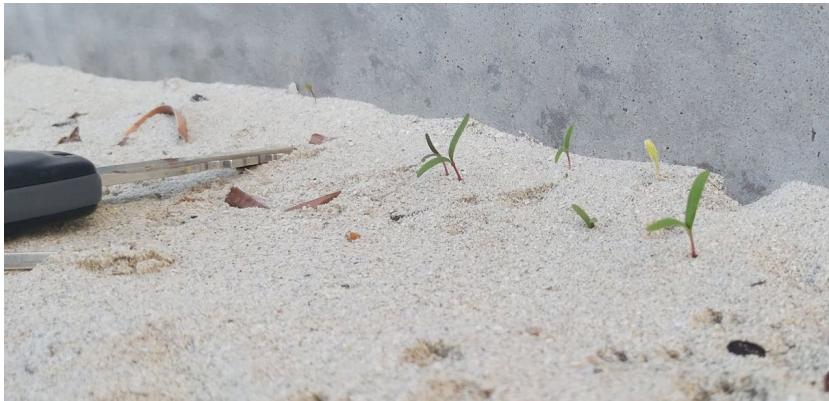
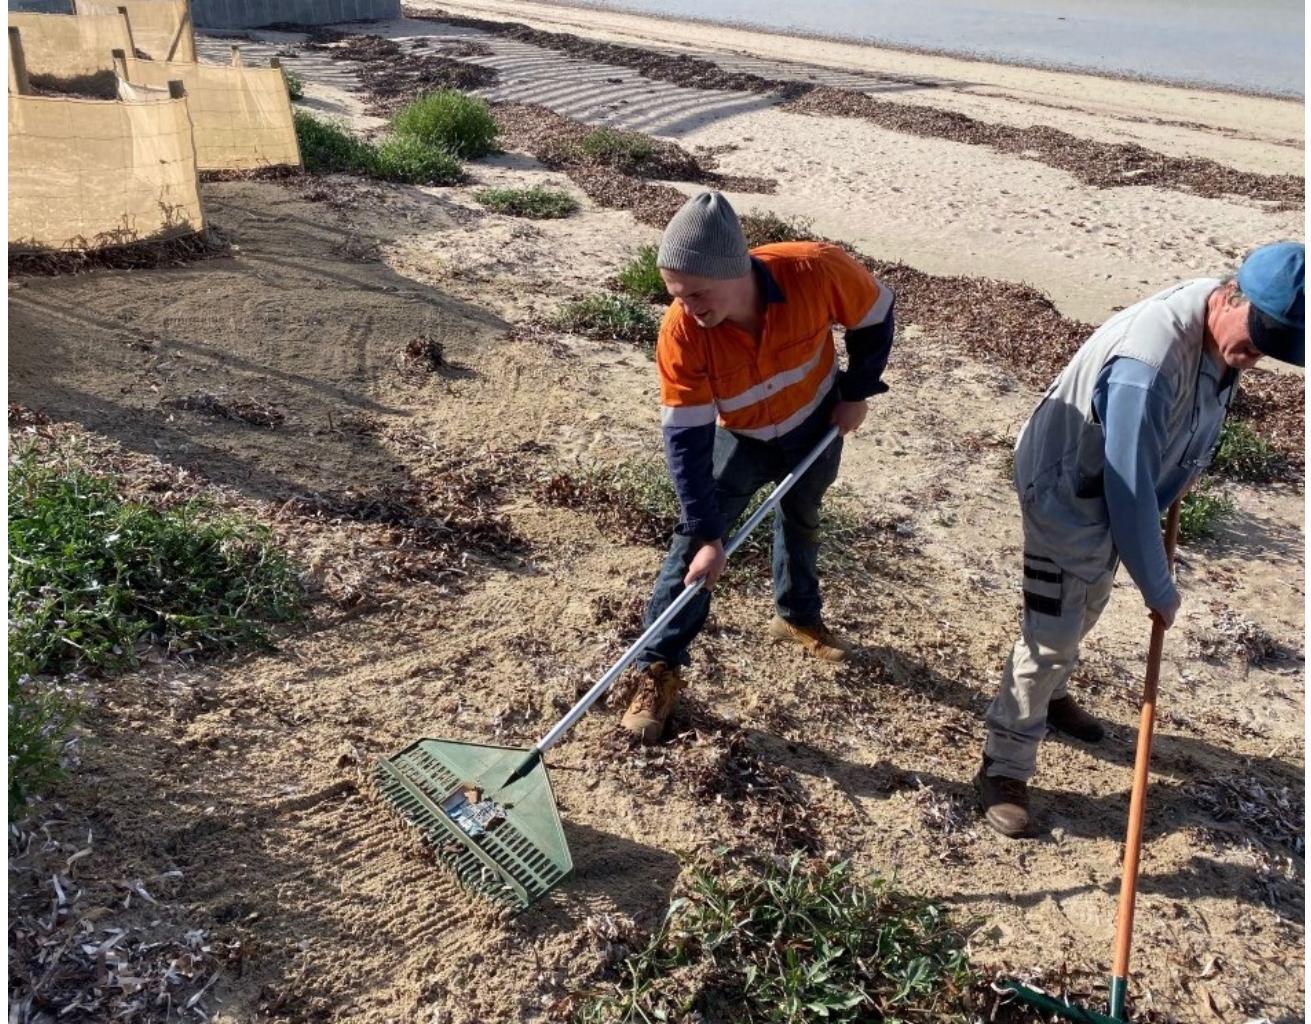
# Second direct seeding project - September 2020

This project involved the harvesting of seed from the western end of the beach, near the mangroves and spreading it the full length of beach, from the Foreshore Caravan Park to the Marina Breakwater. A picture of the germinating seed is pictured below.

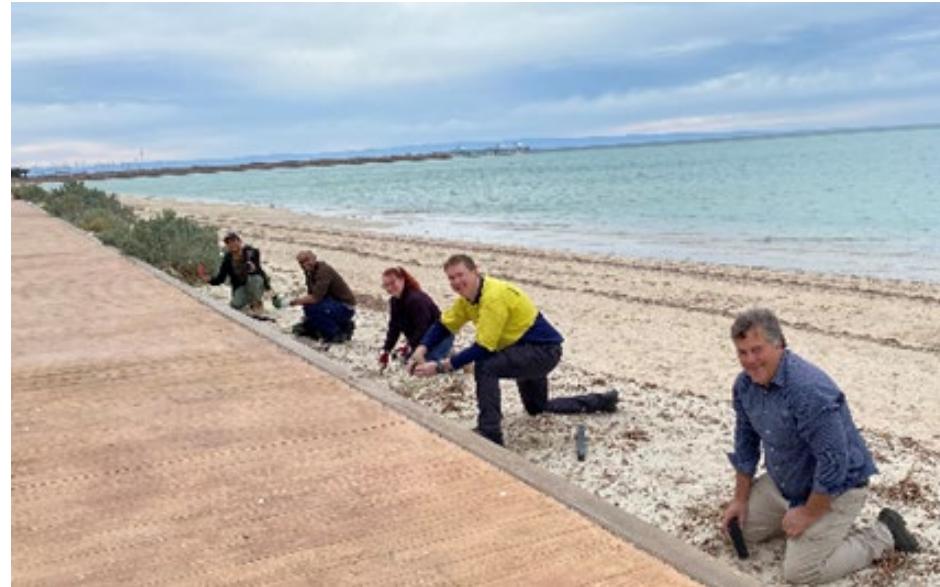
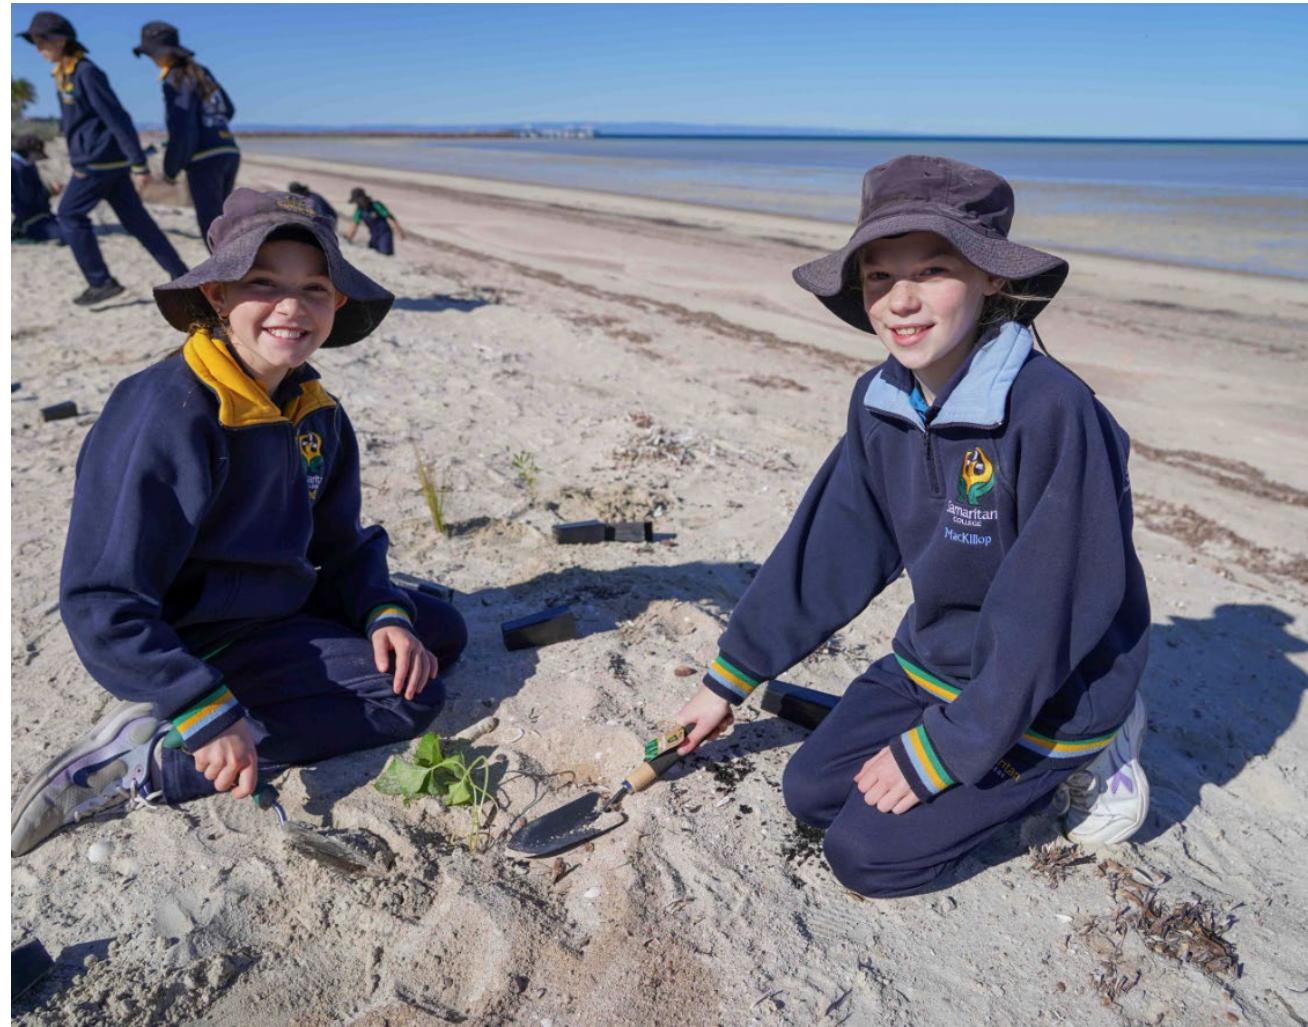
# Ongoing foredune planting

Every year Council purchases tubestock plants to fill in gaps in vegetation growing along the seawall. In August 2024, Local Primary School children helped plant 2000 tubestock to help lock sand in place and provide habitat.

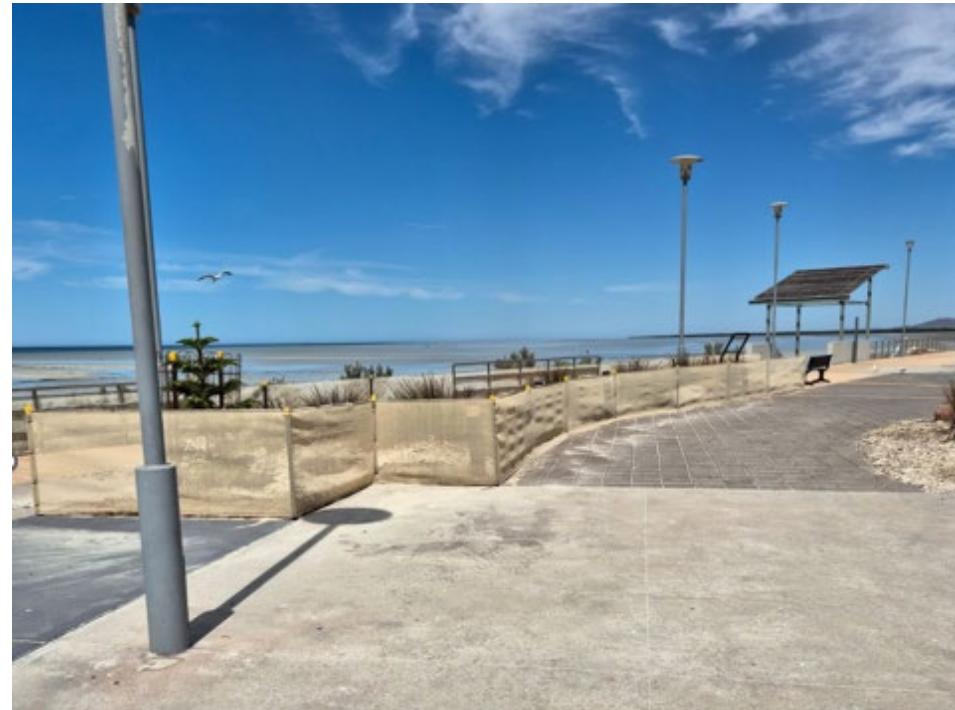
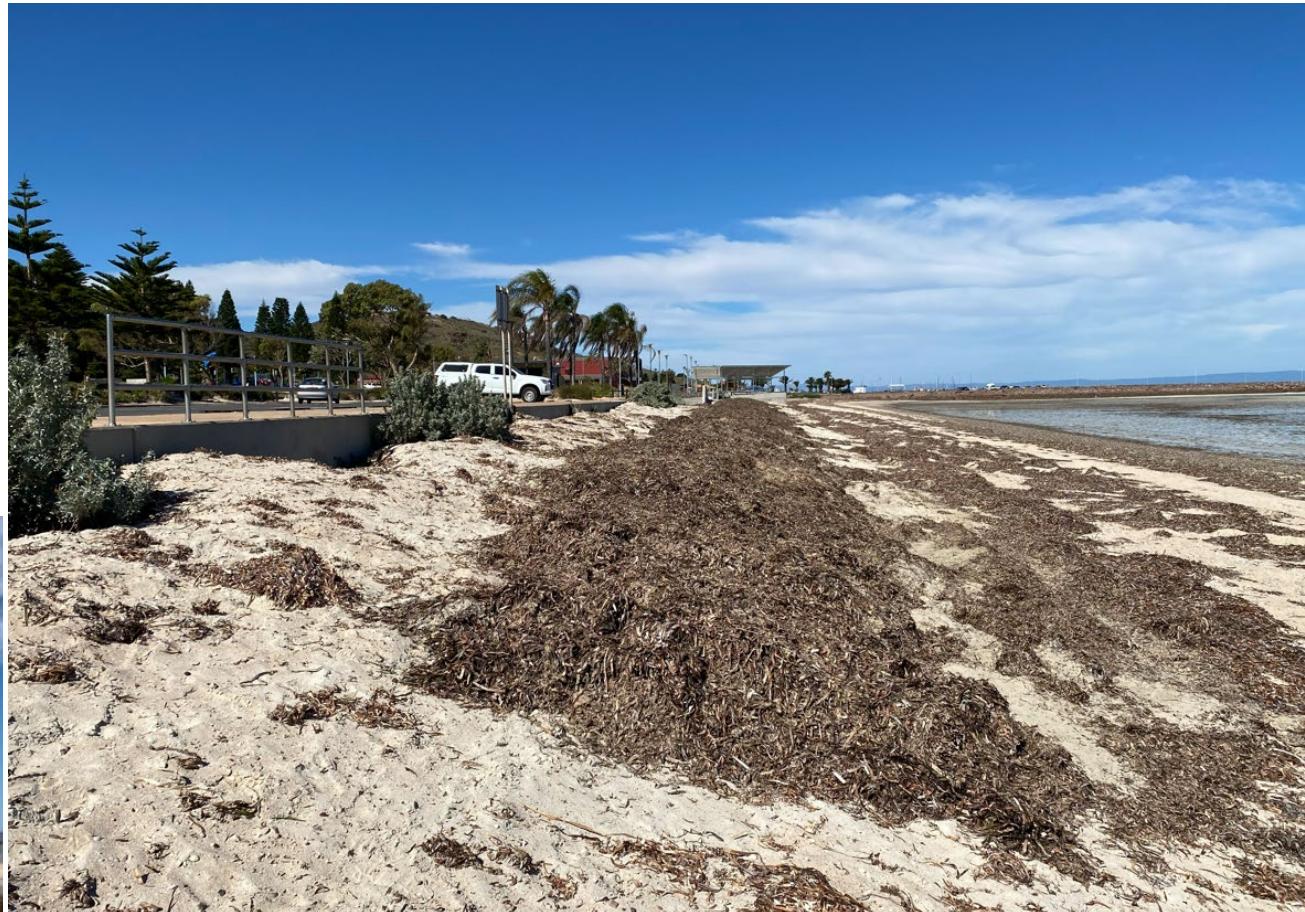
# Control of windblown sand

Council's prevailing SW winds cause a lot of issues with windblown sand. Through ongoing liaison with local residents and the Coast Protection Board, a new best practice method of sand placement has evolved that includes using beach wrack to trap sand and foredune shaping (shown next slide) to allow sand to settle behind the new foredune, before it blows into the promenade behind the seawall. Sand drift fencing has also been used to great effect.

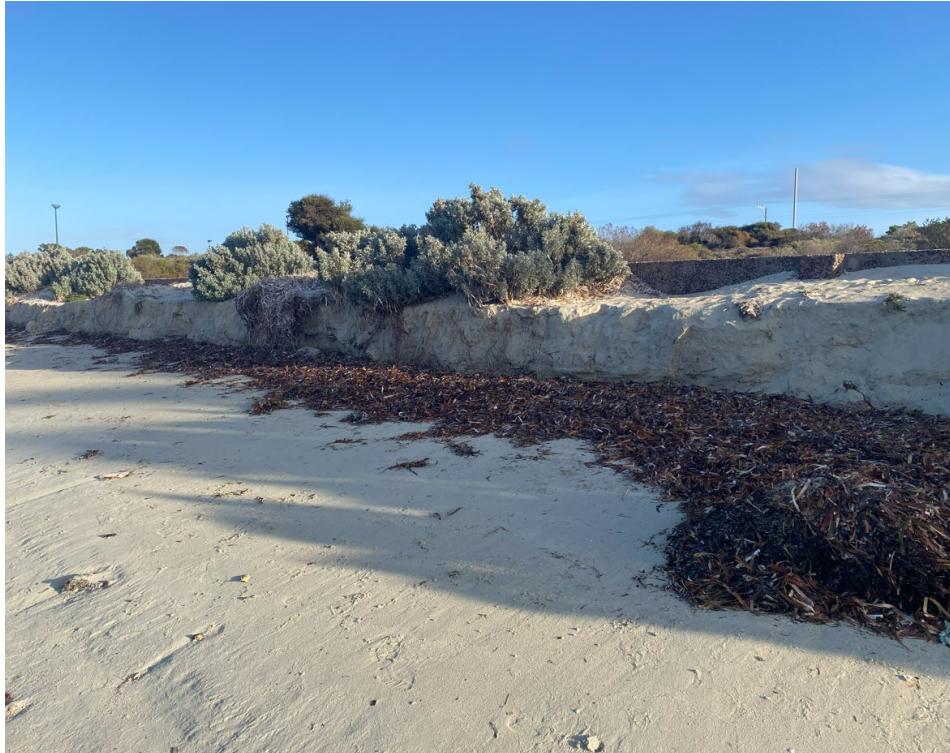
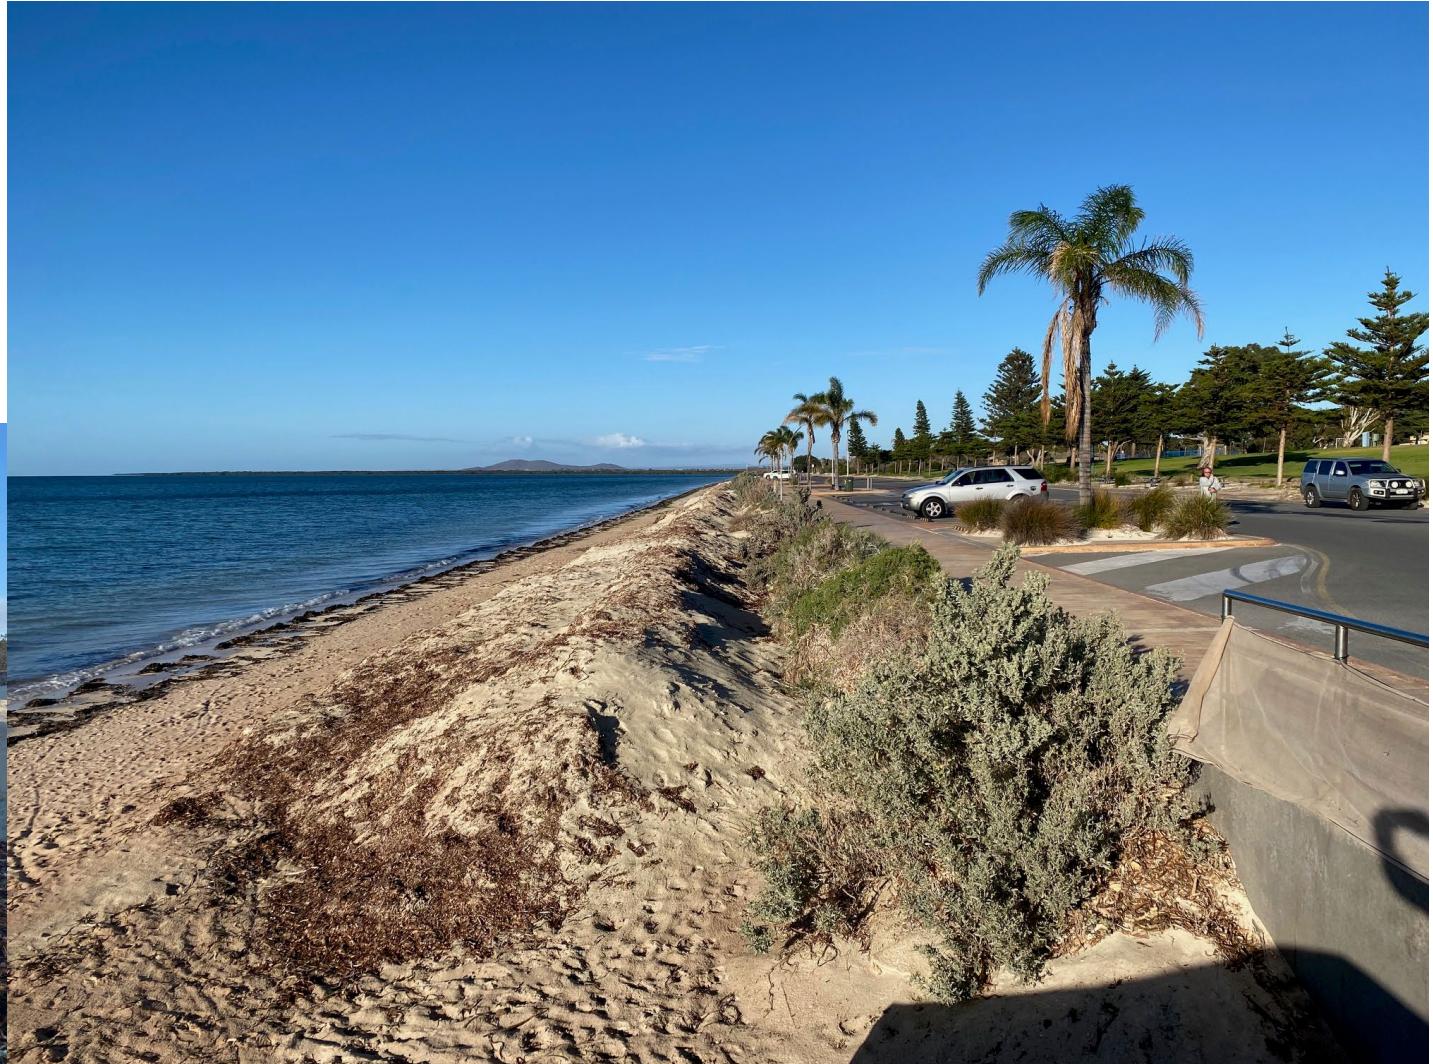
# September 2025 Sand Replenishment Project

Our most recent project replaced the 4500m<sup>3</sup> of sand that was lost during the May 2025 high tide event. As this sand was eroded, it provided a protective buffer against the actions of those tides, preventing any damage to Council's beach side assets.
